Access Compliance Report Public Rights-of-Way (Curb Ramps)

Intersection ID: 29625 Main Street: PLANTERS ROW DR **Cross Street: WINGET RD** Location: NE ADA ID: 4E026AA7AB9D Ramp Type: PerpDiag Initial Pass/Fail: Fail **Overall Compliance: No Severity Score:** 17.5

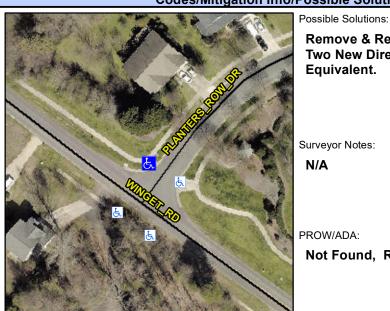
Not Found, R304.5.1

| Field Measurements/Component Compilance | | | | | |
|---|---|---|---|---|---|
| No | Ramp Width (in) | 35.0 | Yes | Ramp XSlope (%) | 0.9 |

Remove & Replace Curb Ramp With Two New Directional Ramps or Equivalent.

Total Cost: 3200.00
