Access Compliance Report

Public Rights-of-Way (Curb Ramps)

Intersection ID: 10038417	Main Street: SOUTH_REA_PARK_LN	Cross Street: N/A	Location:	N
ADA ID: 4E06DD3C9566	Ramp Type: Perp	Initial Pass/Fail: Fail	Overall Compliance: No	Severity Score: 12.5

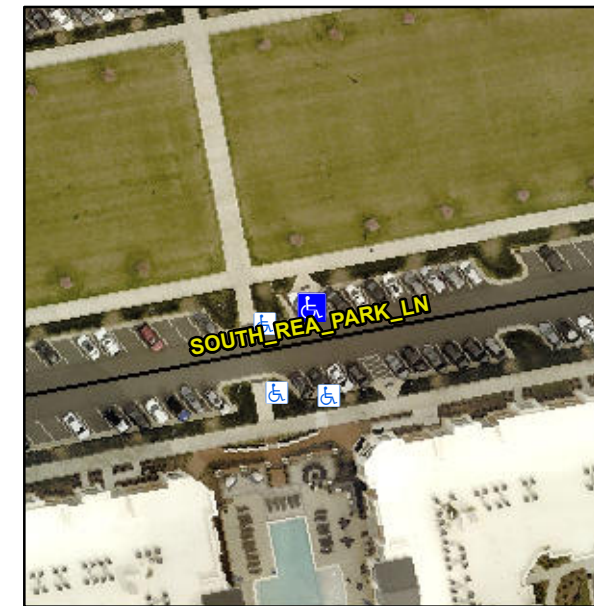
Not Found, R304.2.2

Compliance	Description	Data	Compliance	Description	Data
N/A	Ramp Length (in)	96.0	No	Ramp Slope (%)	8.4
Yes	Ramp Width (in)	59.0	Yes	Ramp XSlope (%)	1.6
N/A	Flare Type LT	N/A	N/A	Flare Type RT	N/A
N/A	Flare Slope LT (%)	N/A	N/A	Flare Slope RT (%)	N/A
N/A	Flare Traversable LT?	N/A	N/A	Flare Traversable RT?	N/A
N/A	Landing Length (in)	N/A	N/A	DWS Provided?	N/A
N/A	Landing Width (in)	N/A	N/A	DWS Contrast?	N/A
N/A	Landing Slope (%)	N/A	N/A	DWS Length (in)	N/A
N/A	Landing X Slope (%)	N/A	N/A	DWS Full Width?	N/A
N/A	Landing Curb? (Y/N)	N/A	N/A	DWS Offset (in)	N/A
N/A	Shared Landing?	N/A			
N/A	Gutter Ponding?	N/A	N/A	Gutter Slope (%)	N/A
N/A	Gutter Lip Ht (in)	N/A	N/A	Gutter X Slope (%)	N/A
N/A	Painted X Walk1?	No	N/A	Painted X Walk2?	N/A
	X Walk 1 Direction	To S		X Walk 2 Direction	N/A
N/A	X Walk 1 Width (in)	N/A	N/A	X Walk 2 Width (in)	N/A
	X Walk 1 Slope (%)	2.5		X Walk 2 Slope (%)	N/A
	X Walk 1 X Slope (%)	0.3		X Walk 2 X Slope (%)	N/A

Remove & Replace Entire Ramp.
