Access Compliance Report

Public Rights-of-Way

(Curb Ramps)

Intersection ID: 18584	Main Street: NOTTINGHAM_DR	Cross Street: ROBINHOOD_RD	Location: E
ADA ID: 4E0CA998BEB7	Ramp Type: PerpDiag	Initial Pass/Fail: Fail	Overall Compliance: No
Severity Score: 8.75			
Codes/Mitigation Info/Possible Solution		Field Measurements/Component Compliance

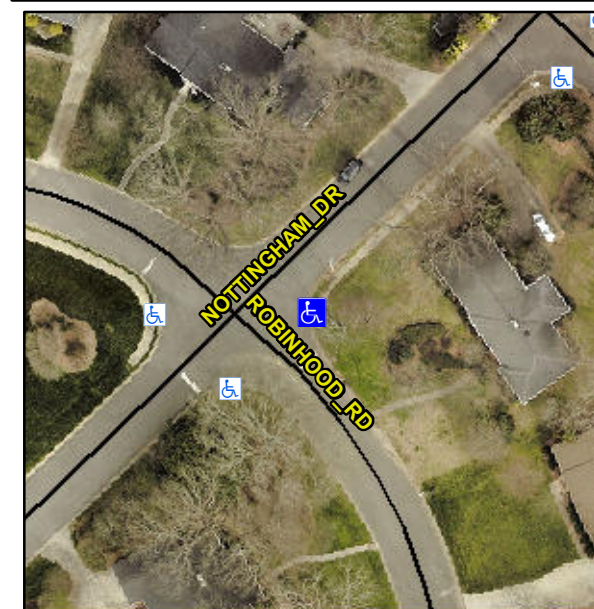
Not Found, R304.5.1

Compliance	Description	Data	Compliance	Description	Data
N/A	Ramp Length (in)	24.5	Yes	Ramp Slope (%)	7.8
No	Ramp Width (in)	44.5	Yes	Ramp XSlope (%)	1.4
N/A	Flare Type LT	N/A	N/A	Flare Type RT	N/A
N/A	Flare Slope LT (%)	N/A	N/A	Flare Slope RT (%)	N/A
N/A	Flare Traversable LT?	N/A	N/A	Flare Traversable RT?	N/A
N/A	Landing Length (in)	N/A	N/A	DWS Provided?	N/A
N/A	Landing Width (in)	N/A	N/A	DWS Contrast?	N/A
N/A	Landing Slope (%)	N/A	N/A	DWS Length (in)	N/A
N/A	Landing X Slope (%)	N/A	N/A	DWS Full Width?	N/A
N/A	Landing Curb? (Y/N)	N/A	N/A	DWS Offset (in)	N/A
N/A	Shared Landing?	N/A			
N/A	Gutter Ponding?	N/A	N/A	Gutter Slope (%)	N/A
N/A	Gutter Lip Ht (in)	N/A	N/A	Gutter X Slope (%)	N/A
N/A	Painted X Walk1?	No	N/A	Painted X Walk2?	No
	X Walk 1 Direction	To NW		X Walk 2 Direction	To SW
N/A	X Walk 1 Width (in)	N/A	N/A	X Walk 2 Width (in)	N/A
	X Walk 1 Slope (%)	1.2		X Walk 2 Slope (%)	0.8
	X Walk 1 X Slope (%)	0.9		X Walk 2 X Slope (%)	2.6

N/A	Ramp inside XWalk1?	N/A	N/A	Ramp inside XWalk2?	N/A
	Road Slope (%)	0.3	N/A	Clear Space?	N/A
	Road X Slope (%)	0.9	N/A	Clear Space to XWalk (in)	N/A
N/A	Any Obstructions?	N/A	N/A	Storm Grate/Utility Hazard?	N/A
	Obstruction Type			Storm Grate/Utility Type	
		N/A			N/A
			Yes	Surface Condition? (G/P)	Good

Remove & Replace Curb Ramp With Two New Directional Ramps or Equivalent.
