Access Compliance Report

Public Rights-of-Way

(Curb Ramps)

| Intersection ID: 48950 | Main Street: DAVID_JENNINGS_AV | Cross Street: BONROI_AV | Location: E |

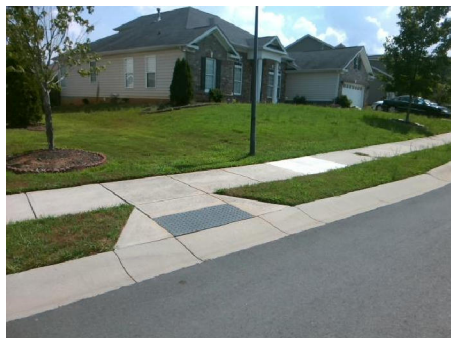
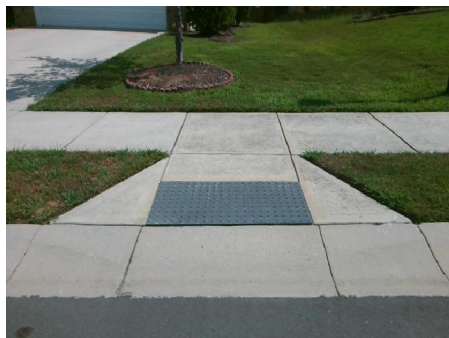
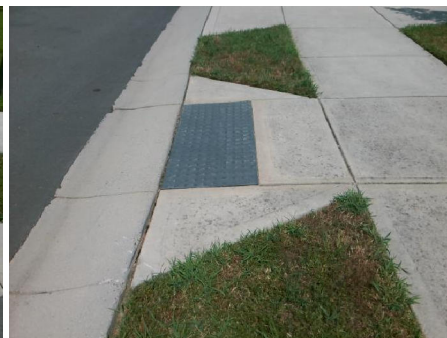
Not Found, R304.5.4

| Compliance | Description | Data | Compliance | Description | Data |
|---|---|---|---|---|---|
| Yes | Gutter Ponding? | No | No | Gutter Slope (%) | 9.8 |

**Remove & Replace Entire Ramp.
Remove & Replace Gutter.**
