Access Compliance Report

Public Rights-of-Way

(Curb Ramps)

Intersection ID: 30131	Main Street: WADENA_DR	Cross Street: HARLAND_ST	Location: NW
ADA ID: 4E23DC3725B6	Ramp Type: PerpDiag	Initial Pass/Fail: Pass	Overall Compliance: No
Codes/Mitigation Info/Possible Solution		Field Measurements/Component Compliance

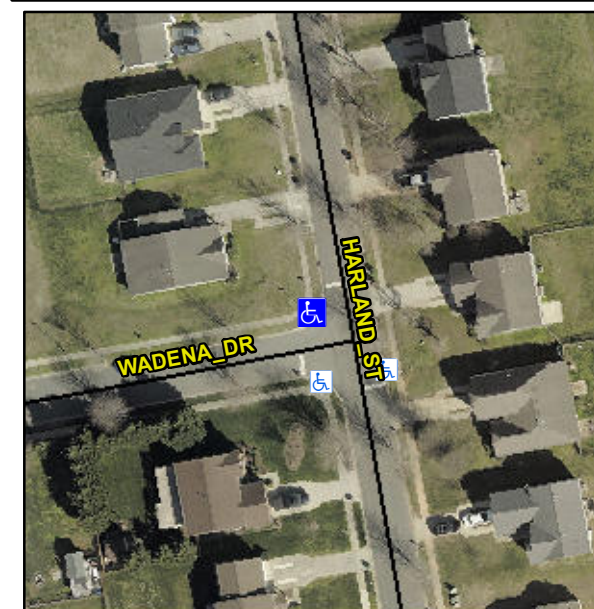
Not Found, R304.2.2-Perp, R304.3.2-Para, R305.2

Compliance	Description	Data	Compliance	Description	Data
N/A	Ramp Length (in)	42.0	Yes	Ramp Slope (%)	5.5
Yes	Ramp Width (in)	48.0	Yes	Ramp XSlope (%)	1.9
N/A	Flare Type LT	Sloped	N/A	Flare Type RT	N/A
N/A	Flare Slope LT (%)	3.0	Yes	Flare Slope RT (%)	2.0
N/A	Flare Traversable LT?	Yes	N/A	Flare Traversable RT?	Yes
Yes	Landing Length (in)	50.5	Yes	DWS Provided?	Yes
Yes	Landing Width (in)	48.0	Yes	DWS Contrast?	Yes
No	Landing Slope (%)	5.4	Yes	DWS Length (in)	25.5
Yes	Landing X Slope (%)	1.7	Yes	DWS Full Width?	Yes
N/A	Landing Curb? (Y/N)	No	No	DWS Offset (in)	2.5
N/A	Shared Landing?	No			
Yes	Gutter Ponding?	No	Yes	Gutter Slope (%)	3.1
Yes	Gutter Lip Ht (in)	0.0	Yes	Gutter X Slope (%)	1.9
N/A	Painted X Walk1?	No	N/A	Painted X Walk2?	No
	X Walk 1 Direction	To S		X Walk 2 Direction	To E
N/A	X Walk 1 Width (in)	N/A	N/A	X Walk 2 Width (in)	N/A
	X Walk 1 Slope (%)	0.6		X Walk 2 Slope (%)	3.8
	X Walk 1 X Slope (%)	1.5		X Walk 2 X Slope (%)	1.5

N/A	Ramp inside XWalk1?	N/A	N/A	Ramp inside XWalk2?	N/A
	Road Slope (%)	3.0	N/A	Clear Space?	Yes
	Road X Slope (%)	1.6	N/A	Clear Space to XWalk (in)	N/A
Yes	Any Obstructions?	No	Yes	Storm Grate/Utility Hazard?	No
	Obstruction Type			Storm Grate/Utility Type	
			N/A		N/A
			Yes	Surface Condition? (G/P)	Good

Remove & Replace Curb Ramp With Two New Directional Ramps or Equivalent.

Total Cost: \$ 3200.00
