Access Compliance Report

Public Rights-of-Way

(Curb Ramps)

Intersection ID: 49254	Main Street: OAKBURN_DR	Cross Street: LEGATO_LN	Location: SW
ADA ID: 4E274D0DC133	Ramp Type: Perp	Initial Pass/Fail: Fail	Overall Compliance: No
Severity Score: 35			
Codes/Mitigation Info/Possible Solution		Field Measurements/Component Compliance

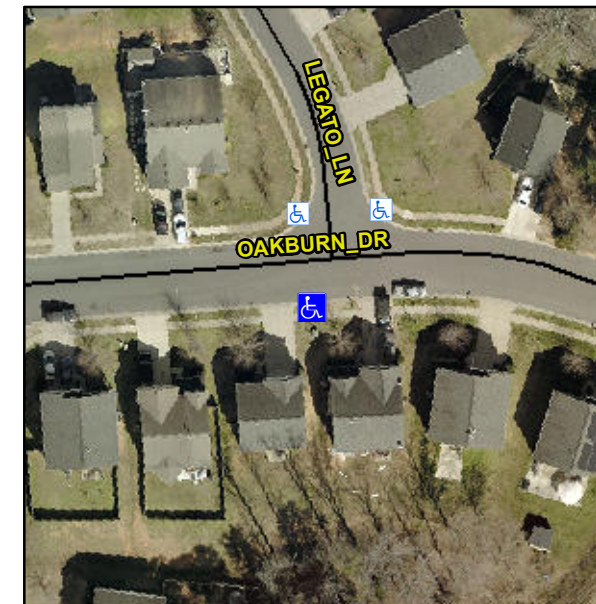
Not Found, R304.5.1, R304.2.2

Compliance	Description	Data	Compliance	Description	Data
N/A	Ramp Length (in)	46.5	No	Ramp Slope (%)	20.0
No	Ramp Width (in)	47.5	Yes	Ramp XSlope (%)	4.0
N/A	Flare Type LT	N/A	N/A	Flare Type RT	N/A
N/A	Flare Slope LT (%)	N/A	N/A	Flare Slope RT (%)	N/A
N/A	Flare Traversable LT?	N/A	N/A	Flare Traversable RT?	N/A
N/A	Landing Length (in)	N/A	N/A	DWS Provided?	N/A
N/A	Landing Width (in)	N/A	N/A	DWS Contrast?	N/A
N/A	Landing Slope (%)	N/A	N/A	DWS Length (in)	N/A
N/A	Landing X Slope (%)	N/A	N/A	DWS Full Width?	N/A
N/A	Landing Curb? (Y/N)	N/A	N/A	DWS Offset (in)	N/A
N/A	Shared Landing?	N/A			
N/A	Gutter Ponding?	N/A	N/A	Gutter Slope (%)	N/A
N/A	Gutter Lip Ht (in)	N/A	N/A	Gutter X Slope (%)	N/A
N/A	Painted X Walk1?	No	N/A	Painted X Walk2?	N/A
	X Walk 1 Direction	To N		X Walk 2 Direction	N/A
N/A	X Walk 1 Width (in)	N/A	N/A	X Walk 2 Width (in)	N/A
	X Walk 1 Slope (%)	1.0		X Walk 2 Slope (%)	N/A
	X Walk 1 X Slope (%)	4.1		X Walk 2 X Slope (%)	N/A

N/A	Ramp inside XWalk1?	N/A	N/A	Ramp inside XWalk2?	N/A
	Road Slope (%)	N/A	N/A	Clear Space?	N/A
	Road X Slope (%)	N/A	N/A	Clear Space to XWalk (in)	N/A
N/A	Any Obstructions?	N/A	N/A	Storm Grate/Utility Hazard?	N/A
	Obstruction Type			Storm Grate/Utility Type	
		N/A			N/A
			Yes	Surface Condition? (G/P)	Good

Remove & Replace Entire Ramp.
