Access Compliance Report

Public Rights-of-Way (Curb Ramps)

Intersection ID: 30124	Main Street: CLOONEY_LN	Cross Street: OLDE_JUSTIN_PL	Location: SE
ADA ID: 4E27C8297595	Ramp Type: BlendTrans1	Initial Pass/Fail: Fail	Overall Compliance: No
		Severity Score: 8.75

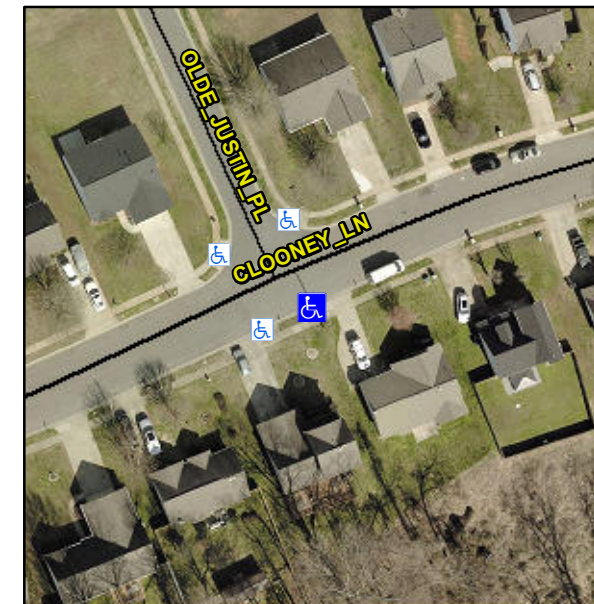
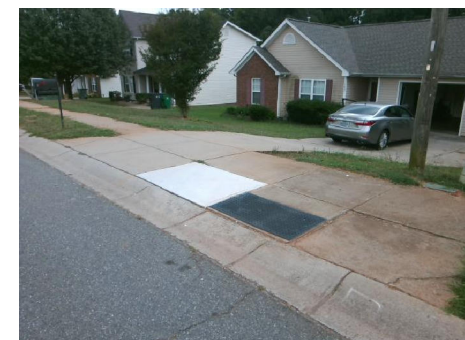
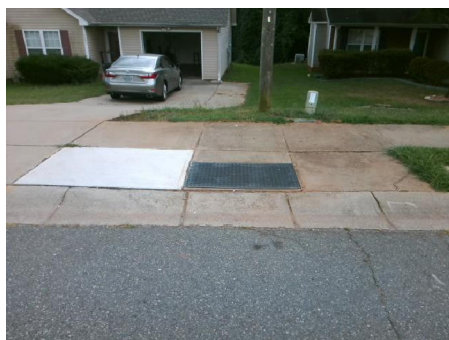
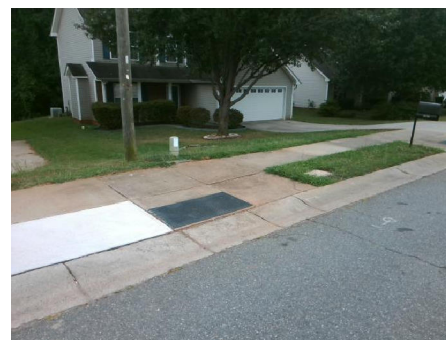
Compliance	Description	Data	Compliance	Description	Data
N/A	Ramp Length (in)	44.0	Yes	BlendTrans Slope (%)	4.6
No	Ramp Width (in)	40.0	Yes	BlendTrans XSlope (%)	0.9
N/A	Flare Type LT	N/A	N/A	Flare Type RT	N/A
N/A	Flare Slope LT (%)	N/A	N/A	Flare Slope RT (%)	N/A
N/A	Flare Traversable LT?	N/A	N/A	Flare Traversable RT?	N/A
N/A	Landing Length (in)	N/A	N/A	DWS Provided?	N/A
N/A	Landing Width (in)	N/A	N/A	DWS Contrast?	N/A
N/A	Landing Slope (%)	N/A	N/A	DWS Length (in)	N/A
N/A	Landing X Slope (%)	N/A	N/A	DWS Full Width?	N/A
N/A	Landing Curb? (Y/N)	N/A	N/A	DWS Offset (in)	N/A
N/A	Shared Landing?	N/A			
N/A	Gutter Ponding?	N/A	N/A	Gutter Slope (%)	N/A
N/A	Gutter Lip Ht (in)	N/A	N/A	Gutter X Slope (%)	N/A
N/A	Painted X Walk1?	No	N/A	Painted X Walk2?	N/A
	X Walk 1 Direction	To N		X Walk 2 Direction	N/A
	X Walk 1 Width (in)	N/A		X Walk 2 Width (in)	N/A
	X Walk 1 Slope (%)	2.1		X Walk 2 Slope (%)	N/A
	X Walk 1 X Slope (%)	0.3		X Walk 2 X Slope (%)	N/A

N/A	Ramp inside XWalk1?	N/A	N/A	Ramp inside XWalk2?	N/A
	Road Slope (%)	0.3		Clear Space?	N/A
	Road X Slope (%)	2.1	N/A	Clear Space to XWalk (in)	N/A
N/A	Any Obstructions?	N/A	N/A	Storm Grate/Utility Hazard?	N/A
	Obstruction Type			Storm Grate/Utility Type	
		N/A			N/A
			Yes	Surface Condition? (G/P)	Good
			N/A	Curb Slope (%)	N/A

Remove & Replace Curb Ramp With Two New Directional Ramps or Equivalent.

R304.5.1

Total Cost: \$ 3200.00
