# Access Compliance Report

## Public Rights-of-Way

### (Curb Ramps)

Intersection ID: 20760	Main Street: SHARON_RD	Cross Street: SHARON_VIEW_RD	Location: SE
ADA ID: 4E2CB1310B75	Ramp Type: Perp	Initial Pass/Fail: Fail	Overall Compliance: No
Severity Score: 26.25			
Codes/Mitigation Info/Possible Solution		Field Measurements/Component Compliance

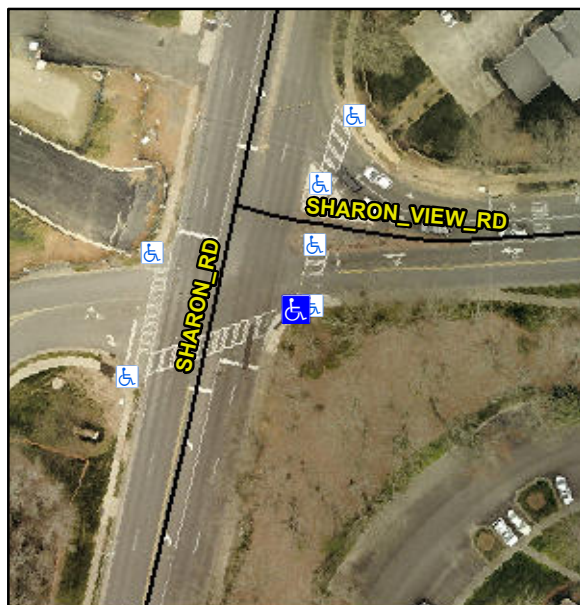
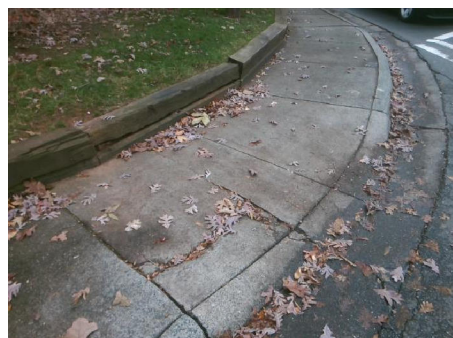
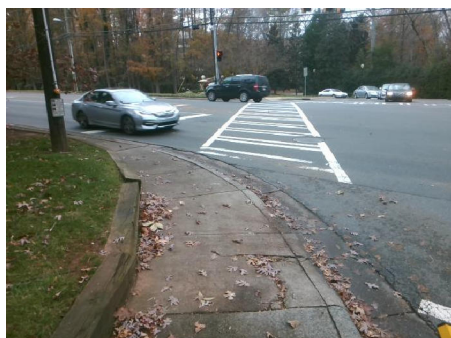
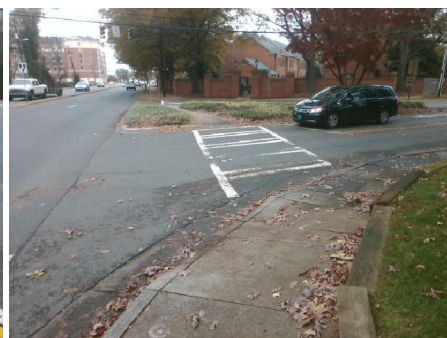
**Not Found, R304.2.2, R304.5.3**

Compliance	Description	Data	Compliance	Description	Data
N/A	Ramp Length (in)	64.0	No	Ramp Slope (%)	12.7
Yes	Ramp Width (in)	48.0	No	Ramp XSlope (%)	4.4
N/A	Flare Type LT	N/A	N/A	Flare Type RT	N/A
N/A	Flare Slope LT (%)	N/A	N/A	Flare Slope RT (%)	N/A
N/A	Flare Traversable LT?	N/A	N/A	Flare Traversable RT?	N/A
N/A	Landing Length (in)	N/A	N/A	DWS Provided?	N/A
N/A	Landing Width (in)	N/A	N/A	DWS Contrast?	N/A
N/A	Landing Slope (%)	N/A	N/A	DWS Length (in)	N/A
N/A	Landing X Slope (%)	N/A	N/A	DWS Full Width?	N/A
N/A	Landing Curb? (Y/N)	N/A	N/A	DWS Offset (in)	N/A
N/A	Shared Landing?	N/A			
N/A	Gutter Ponding?	N/A	N/A	Gutter Slope (%)	N/A
N/A	Gutter Lip Ht (in)	N/A	N/A	Gutter X Slope (%)	N/A
N/A	Painted X Walk1?	Yes	N/A	Painted X Walk2?	N/A
	X Walk 1 Direction	To SW		X Walk 2 Direction	N/A
N/A	X Walk 1 Width (in)	127.0	N/A	X Walk 2 Width (in)	N/A
	X Walk 1 Slope (%)	1.3		X Walk 2 Slope (%)	N/A
	X Walk 1 X Slope (%)	1.4		X Walk 2 X Slope (%)	N/A

N/A	Ramp inside XWalk1?	Yes	N/A	Ramp inside XWalk2?	N/A
	Road Slope (%)	N/A	N/A	Clear Space?	N/A
	Road X Slope (%)	N/A	N/A	Clear Space to XWalk (in)	N/A
N/A	Any Obstructions?	N/A	N/A	Storm Grate/Utility Hazard?	N/A
	Obstruction Type			Storm Grate/Utility Type	
		N/A			N/A
		Yes		Surface Condition? (G/P)	Good

**Remove & Replace Entire Ramp.**
