Access Compliance Report

Public Rights-of-Way (Curb Ramps)

Intersection ID: N/A	Main Street: ALLEGIANCE DR	Cross Street: TANYARD LN	Location: S
ADA ID: 4E3136BDBEB5	Ramp Type: Perp	Initial Pass/Fail: Fail	Overall Compliance: No
Severity Score: 12.5			
Codes/Mitigation Info/Possible Solution		Field Measurements/Component Compliance

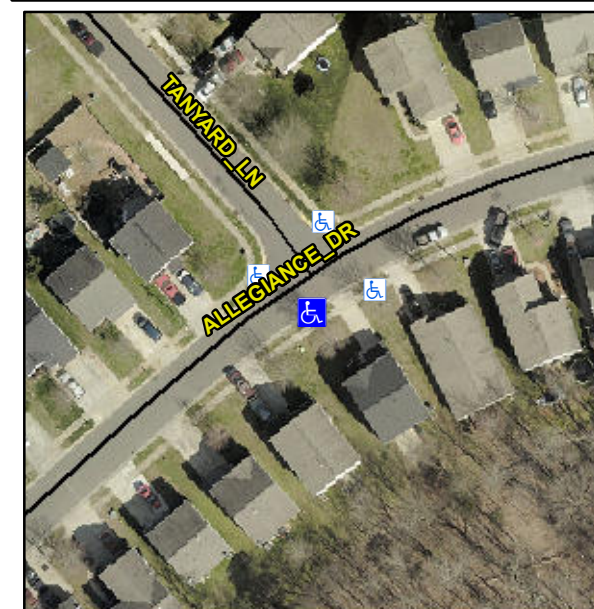
PROW/ADA:

Not Found, R304.2.2

Compliance	Description	Data	Compliance	Description	Data
N/A	Ramp Length (in)	48.0	No	Ramp Slope (%)	9.5
Yes	Ramp Width (in)	49.0	Yes	Ramp XSlope (%)	0.3
N/A	Flare Type LT	N/A	N/A	Flare Type RT	N/A
N/A	Flare Slope LT (%)	N/A	N/A	Flare Slope RT (%)	N/A
N/A	Flare Traversable LT?	No	N/A	Flare Traversable RT?	No
N/A	Landing Length (in)	N/A	N/A	DWS Provided?	N/A
N/A	Landing Width (in)	N/A	N/A	DWS Contrast?	N/A
N/A	Landing Slope (%)	N/A	N/A	DWS Length (in)	N/A
N/A	Landing X Slope (%)	N/A	N/A	DWS Full Width?	N/A
N/A	Landing Curb? (Y/N)	N/A	N/A	DWS Offset (in)	N/A
N/A	Shared Landing?	N/A			
N/A	Gutter Ponding?	N/A	N/A	Gutter Slope (%)	N/A
N/A	Gutter Lip Ht (in)	N/A	N/A	Gutter X Slope (%)	N/A
N/A	Painted X Walk1?	No	N/A	Painted X Walk2?	N/A
	X Walk 1 Direction	To NW		X Walk 2 Direction	N/A
N/A	X Walk 1 Width (in)	N/A	N/A	X Walk 2 Width (in)	N/A
	X Walk 1 Slope (%)	3.4		X Walk 2 Slope (%)	N/A
	X Walk 1 X Slope (%)	2.3		X Walk 2 X Slope (%)	N/A

N/A	Ramp inside XWalk1?	No	N/A	Ramp inside XWalk2?	N/A
	Road Slope (%)	N/A	N/A	Clear Space?	N/A
	Road X Slope (%)	N/A	N/A	Clear Space to XWalk (in)	N/A
N/A	Any Obstructions?	N/A	N/A	Storm Grate/Utility Hazard?	N/A
	Obstruction Type			Storm Grate/Utility Type	
		N/A			N/A
			Yes	Surface Condition? (G/P)	Good

Possible Solutions:

Remove & Replace Entire Ramp.
