# Access Compliance Report

## Public Rights-of-Way

### (Curb Ramps)

Intersection ID: 45063	Main Street: ESCAFLOWNE_AV	Cross Street: REDDING_GLEN_AV	Location: NW
ADA ID: 4E31AE56E4AC	Ramp Type: BlendTrans1	Initial Pass/Fail: Fail	Overall Compliance: No
		Severity Score: 10

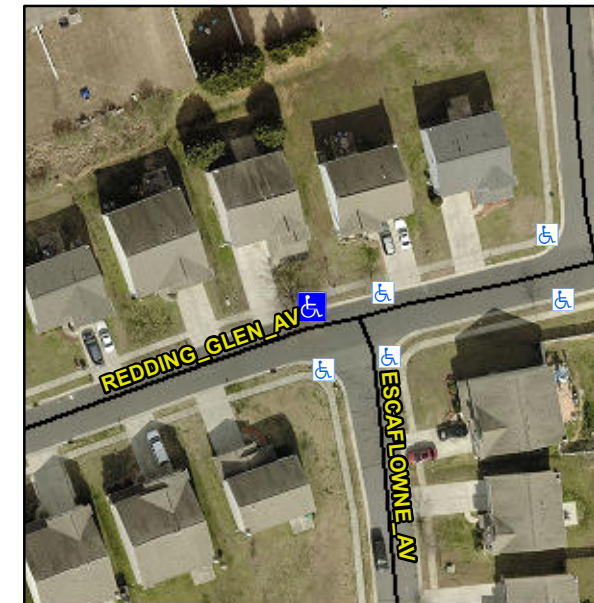
Compliance	Description	Data	Compliance	Description	Data
N/A	Ramp Length (in)	46.0	Yes	BlendTrans Slope (%)	4.5
No	Ramp Width (in)	47.0	Yes	BlendTrans XSlope (%)	2.4
N/A	Flare Type LT	N/A	N/A	Flare Type RT	N/A
N/A	Flare Slope LT (%)	N/A	N/A	Flare Slope RT (%)	N/A
N/A	Flare Traversable LT?	N/A	N/A	Flare Traversable RT?	N/A
N/A	Landing Length (in)	N/A	N/A	DWS Provided?	N/A
N/A	Landing Width (in)	N/A	N/A	DWS Contrast?	N/A
N/A	Landing Slope (%)	N/A	N/A	DWS Length (in)	N/A
N/A	Landing X Slope (%)	N/A	N/A	DWS Full Width?	N/A
N/A	Landing Curb? (Y/N)	N/A	N/A	DWS Offset (in)	N/A
N/A	Shared Landing?	N/A			
N/A	Gutter Ponding?	N/A	N/A	Gutter Slope (%)	N/A
N/A	Gutter Lip Ht (in)	N/A	N/A	Gutter X Slope (%)	N/A
N/A	Painted X Walk1?	No	N/A	Painted X Walk2?	N/A
	X Walk 1 Direction	To S		X Walk 2 Direction	N/A
	X Walk 1 Width (in)	N/A		X Walk 2 Width (in)	N/A
	X Walk 1 Slope (%)	5.5		X Walk 2 Slope (%)	N/A
	X Walk 1 X Slope (%)	4.5		X Walk 2 X Slope (%)	N/A

N/A	Ramp inside XWalk1?	N/A	N/A	Ramp inside XWalk2?	N/A
	Road Slope (%)	4.5		Clear Space?	N/A
	Road X Slope (%)	5.5	N/A	Clear Space to XWalk (in)	N/A
N/A	Any Obstructions?	N/A	N/A	Storm Grate/Utility Hazard?	N/A
	Obstruction Type			Storm Grate/Utility Type	
		N/A			N/A
			Yes	Surface Condition? (G/P)	Good
			N/A	Curb Slope (%)	4.5

**Remove & Replace Curb Ramp With Two New Directional Ramps or Equivalent.**

**R304.5.1**
