# Access Compliance Report

## Public Rights-of-Way

| Intersection ID: 43514 | Main Street: BLACKBERRY RIDGE LN | Cross Street: MULBERRY POND DR | Location: W |
| ADA ID: 4E3DA76E1286 | Ramp Type: PerpDiag | Initial Pass/Fail: Pass | Overall Compliance: No |

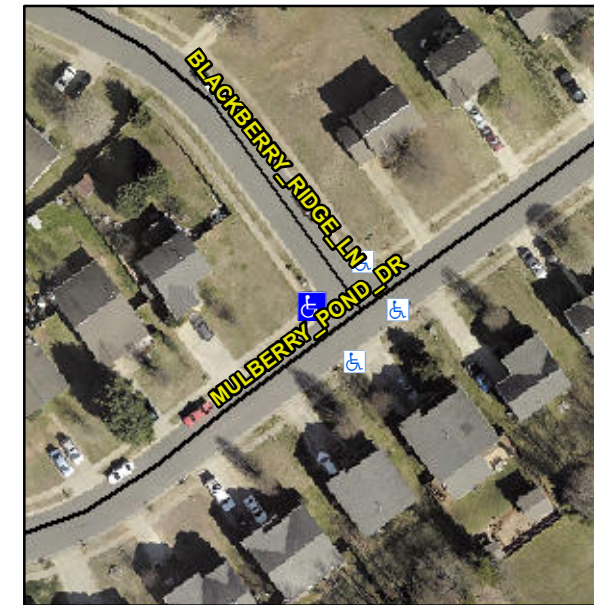
| Compliance | Description | Data | Compliance | Description | Data |
|---|---|---|---|---|---|
| Yes | Landing X Slope (%) | 1.9 | No | DWS Full Width? | No |
| N/A | Landing Curb? (Y/N) | No | No | DWS Offset (in) | 3.0 |
| Yes | Gutter Ponding? | No | No | Gutter Slope (%) | 8.3 |

**Remove & Replace Detectable Warning System. Remove & Replace Gutter.**

**R305.1.4, R305.2, R304.5.4**
