# Access Compliance Report

## Public Rights-of-Way

### (Curb Ramps)

Intersection ID: 16086	Main Street: HOLLIS_RD	Cross Street: WESTON_ST	Location: NW
ADA ID: 4E45EC588C46	Ramp Type: Directional1	Initial Pass/Fail: Fail	Overall Compliance: No
Codes/Mitigation Info/Possible Solution		Field Measurements/Component Compliance	
Severity Score: 13.75

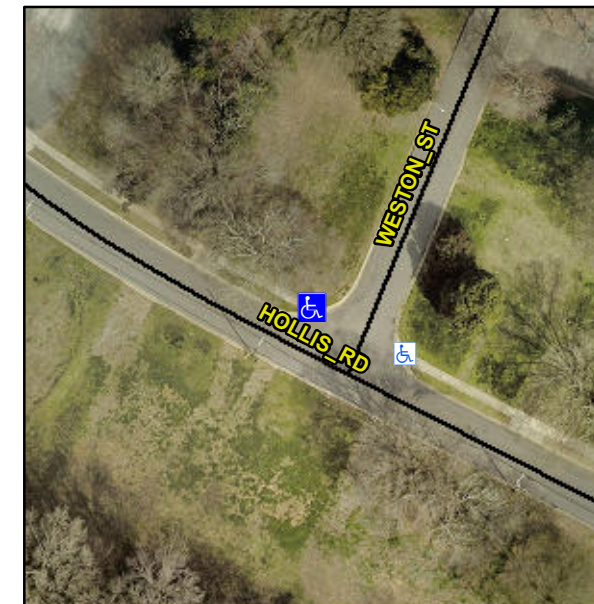
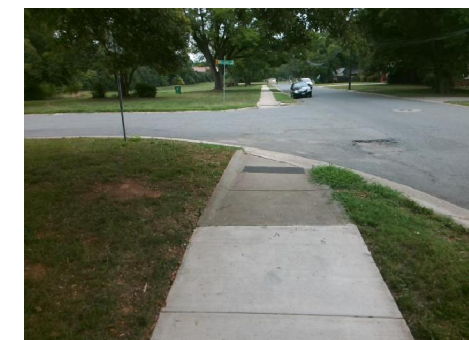
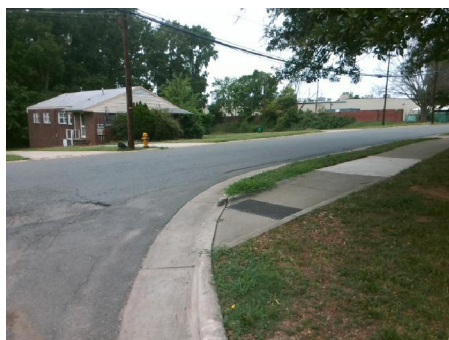
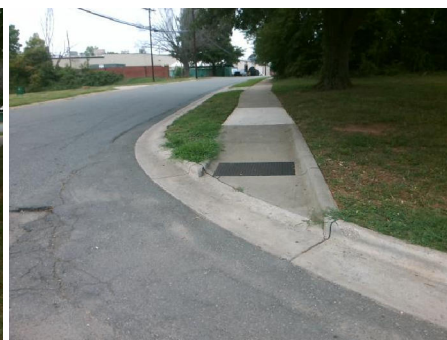
**R304.2.2, R304.5.3**

Compliance	Description	Data	Compliance	Description	Data
N/A	Ramp Length (in)	130.0	N/A	Grade Break?	N/A
Yes	Ramp Width (in)	56.0	N/A	Grade Break Slope (%)	0.0
No	Ramp Slope (%)	10.1	N/A	Grade Break XSlope (%)	0.0
No	Ramp XSlope (%)	3.0			
N/A	Flare Type LT	N/A	N/A	Flare Type RT	N/A
N/A	Flare Slope LT (%)	N/A	N/A	Flare Slope RT (%)	0.0
N/A	Flare Traversable LT?	N/A	N/A	Flare Traversable RT?	N/A
N/A	Landing Length (in)	0.0	N/A	DWS Provided?	N/A
N/A	Landing Width (in)	0.0	N/A	DWS Contrast?	N/A
N/A	Landing Slope (%)	0.0	N/A	DWS Length (in)	N/A
N/A	Landing X Slope (%)	0.0	N/A	DWS Full Width?	N/A
N/A	Landing Curb? (Y/N)	N/A	N/A	DWS Offset LT (in)	N/A
N/A	Shared Landing?	N/A	N/A	DWS Offset RT (in)	N/A
N/A	Gutter Ponding?	0.0	N/A	Gutter Slope (%)	N/A
N/A	Gutter Lip Ht (in)	0.0	N/A	Gutter X Slope (%)	N/A
N/A	Painted X Walk1?	No		Road Slope (%)	1.9
	X Walk 1 Direction	To E		Road X Slope (%)	0.2
	X Walk 1 Width (in)	N/A		Clear Space?	N/A

X Walk 1 Slope (%)	1.9	N/A	Clear Space to XWalk (in)	N/A
	X Walk 1 X Slope (%)	0.2	N/A	Storm Grate/Utility Hazard?	N/A
N/A	Ramp inside XWalk1?	N/A		Storm Grate/Utility Type	
N/A	Any Obstructions?	N/A			N/A
	Obstruction Type		Yes	Surface Condition? (G/P)	Good
			N/A	Curb Slope (%)	21.5

**Remove & Replace Entire Ramp.**
