Access Compliance Report

Public Rights-of-Way

(Curb Ramps)

Intersection ID: 10034401	Main Street: PIEDMONT_PARK_DR	Cross Street: SAGE_PARK_DR	Location: W
ADA ID: 4E492CCB39FC	Ramp Type: Directional1	Initial Pass/Fail: Fail	Overall Compliance: No
Severity Score: 13.75			
Codes/Mitigation Info/Possible Solution		Field Measurements/Component Compliance

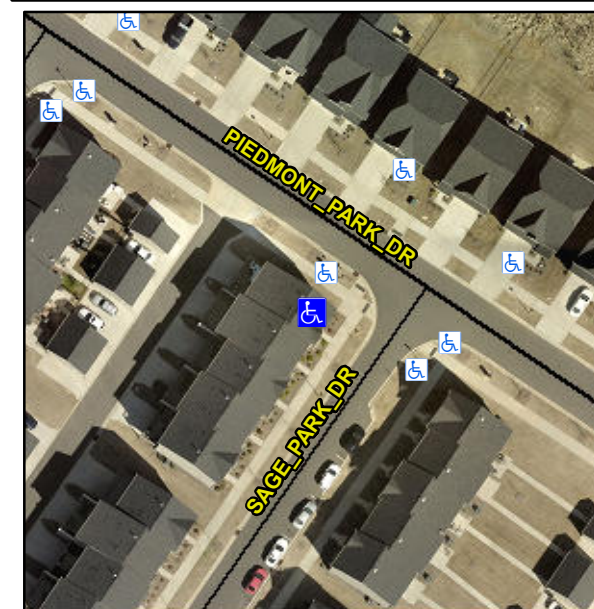
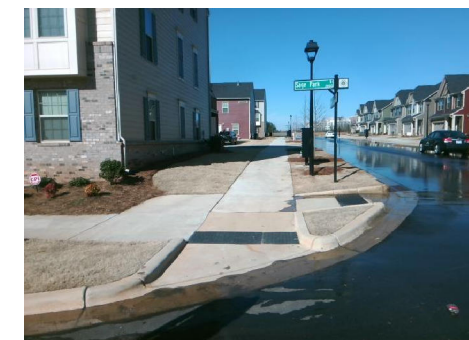
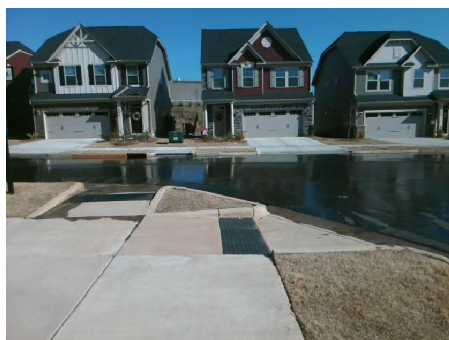
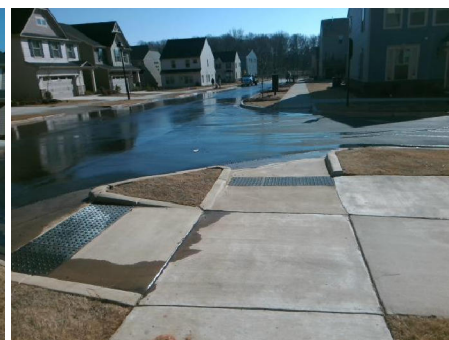
R304.2.2, R304.5.3

Compliance	Description	Data	Compliance	Description	Data
N/A	Ramp Length (in)	76.0	N/A	Grade Break?	N/A
Yes	Ramp Width (in)	71.0	N/A	Grade Break Slope (%)	0.0
No	Ramp Slope (%)	8.7	N/A	Grade Break XSlope (%)	0.0
No	Ramp XSlope (%)	4.2			
N/A	Flare Type LT	N/A	N/A	Flare Type RT	N/A
N/A	Flare Slope LT (%)	N/A	N/A	Flare Slope RT (%)	0.0
N/A	Flare Traversable LT?	N/A	N/A	Flare Traversable RT?	N/A
N/A	Landing Length (in)	0.0	N/A	DWS Provided?	N/A
N/A	Landing Width (in)	0.0	N/A	DWS Contrast?	N/A
N/A	Landing Slope (%)	0.0	N/A	DWS Length (in)	N/A
N/A	Landing X Slope (%)	0.0	N/A	DWS Full Width?	N/A
N/A	Landing Curb? (Y/N)	N/A	N/A	DWS Offset LT (in)	N/A
N/A	Shared Landing?	N/A	N/A	DWS Offset RT (in)	N/A
N/A	Gutter Ponding?	0.0	N/A	Gutter Slope (%)	N/A
N/A	Gutter Lip Ht (in)	0.0	N/A	Gutter X Slope (%)	N/A
N/A	Painted X Walk1?	No		Road Slope (%)	0.4
	X Walk 1 Direction	To SE		Road X Slope (%)	2.9
	X Walk 1 Width (in)	N/A		Clear Space?	N/A

X Walk 1 Slope (%)	0.4	N/A	Clear Space to XWalk (in)	N/A
	X Walk 1 X Slope (%)	2.9	N/A	Storm Grate/Utility Hazard?	N/A
N/A	Ramp inside XWalk1?	N/A		Storm Grate/Utility Type	
N/A	Any Obstructions?	N/A			N/A
	Obstruction Type		Yes	Surface Condition? (G/P)	Good
			N/A	Curb Slope (%)	4.5

Remove & Replace Entire Ramp.
