Access Compliance Report

Public Rights-of-Way

(Curb Ramps)

Intersection ID: 54461	Main Street: FENWAY_DR	Cross Street: FLINT_HILL_DR	Location: SE
ADA ID: 4E51C5DFF285	Ramp Type: Perp	Initial Pass/Fail: Pass	Overall Compliance: No
Codes/Mitigation Info/Possible Solution			Severity Score: 20
			Field Measurements/Component Compliance

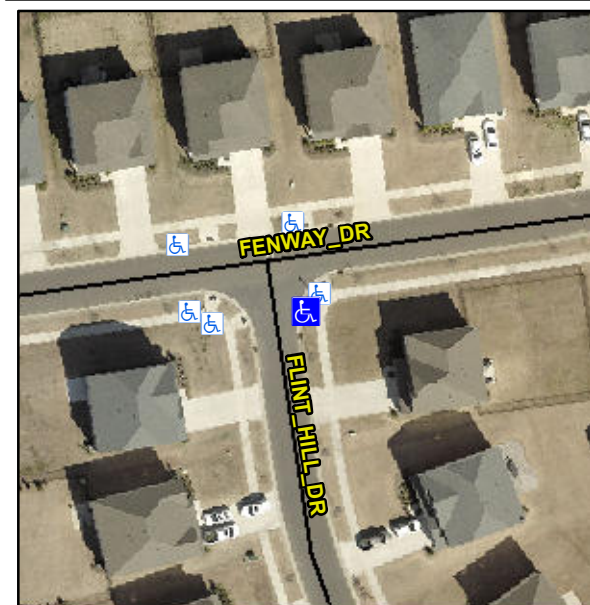
R305.2, R302.7.2, R304.5.4

Compliance	Description	Data	Compliance	Description	Data
N/A	Ramp Length (in)	96.0	Yes	Ramp Slope (%)	5.2
Yes	Ramp Width (in)	48.0	Yes	Ramp XSlope (%)	0.2
N/A	Flare Type LT	Sloped	N/A	Flare Type RT	N/A
N/A	Flare Slope LT (%)	2.5	Yes	Flare Slope RT (%)	0.2
N/A	Flare Traversable LT?	Yes	N/A	Flare Traversable RT?	Yes
Yes	Landing Length (in)	60.0	Yes	DWS Provided?	Yes
Yes	Landing Width (in)	48.0	Yes	DWS Contrast?	Yes
Yes	Landing Slope (%)	0.7	Yes	DWS Length (in)	24.0
Yes	Landing X Slope (%)	0.2	Yes	DWS Full Width?	Yes
N/A	Landing Curb? (Y/N)	No	No	DWS Offset (in)	5.0
N/A	Shared Landing?	No			
Yes	Gutter Ponding?	No	No	Gutter Slope (%)	6.6
No	Gutter Lip Ht (in)	1.0	Yes	Gutter X Slope (%)	1.0
N/A	Painted X Walk1?	No	N/A	Painted X Walk2?	N/A
	X Walk 1 Direction	To W		X Walk 2 Direction	N/A
N/A	X Walk 1 Width (in)	N/A	N/A	X Walk 2 Width (in)	N/A
	X Walk 1 Slope (%)	1.2		X Walk 2 Slope (%)	N/A
	X Walk 1 X Slope (%)	0.1		X Walk 2 X Slope (%)	N/A

N/A	Ramp inside XWalk1?	N/A	N/A	Ramp inside XWalk2?	N/A
	Road Slope (%)	N/A	N/A	Clear Space?	Yes
	Road X Slope (%)	N/A	N/A	Clear Space to XWalk (in)	N/A
Yes	Any Obstructions?	No	Yes	Storm Grate/Utility Hazard?	No
	Obstruction Type			Storm Grate/Utility Type	
		N/A			N/A
			Yes	Surface Condition? (G/P)	Good

Possible Solutions:

Remove & Replace Detectable Warning System. Remove & Replace Gutter.
