Access Compliance Report

Public Rights-of-Way

(Curb Ramps)

Intersection ID: 45130	Main Street: DULIN_CREEK_BV	Cross Street: PLAZA_RD_EXT	Location: NE
ADA ID: 4E54ACC5B613	Ramp Type: Combination1	Initial Pass/Fail: Fail	Overall Compliance: No
			Severity Score: 31.25

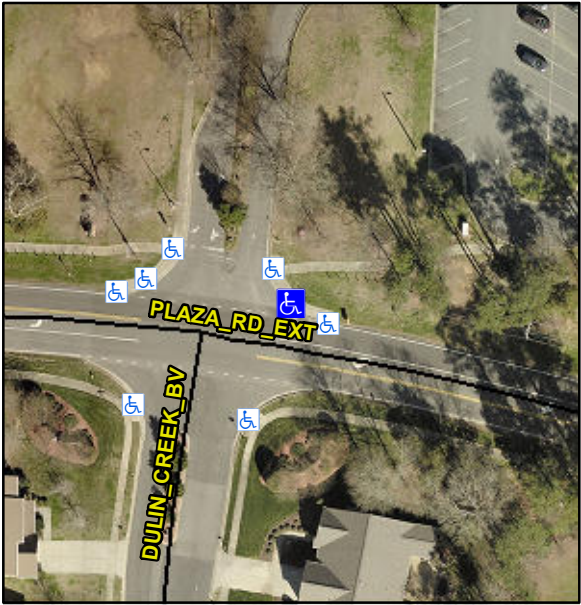
Possible Solutions:		Compliance	Description	Data
	Remove & Replace Entire Ramp.		N/A	Ramp Length LT (in)	59.0
			No	Ramp Width LT (in)	35.5
			No	Ramp Slope LT (%)	9.2
			No	Ramp XSlope LT (%)	3.0
			N/A	Ramp Length (in)	24.0
			Yes	Ramp Width (in)	48.0
			N/A	Flare Type LT	N/A
			N/A	Flare Slope LT (%)	N/A
			N/A	Flare Traversable LT?	N/A
<p>Surveyor Notes:</p> <p>N/A</p> <p>PROW/ADA:</p> <p>Not Found, R304.5.1, R304.5.3, R304.3.2</p>			N/A	Ramp Slope RT (%)	7.3
			No	Ramp XSlope RT (%)	2.1
			Yes	Ramp Slope (%)	4.3
			No	Ramp XSlope (%)	2.5
			N/A	Flare Type RT	N/A
			N/A	Flare Slope RT (%)	N/A
			N/A	Flare Traversable RT?	N/A
			N/A	DWS Provided?	N/A
			N/A	DWS Contrast?	N/A
			N/A	DWS Length (in)	N/A
			N/A	DWS Full Width?	N/A
			N/A	DWS Offset (in)	N/A
			N/A	Shared Landing?	N/A
			N/A	Gutter Ponding?	N/A
			N/A	Gutter Lip Ht (in)	N/A

N/A	Painted X Walk1?	No
				X Walk 1 Direction	To S
				X Walk 1 Width (in)	N/A
				X Walk 1 Slope (%)	3.3
				X Walk 1 X Slope (%)	0.8
			N/A	Ramp inside XWalk1?	N/A
				Road Slope (%)	N/A
				Road X Slope (%)	N/A
			N/A	Ramp inside XWalk2?	N/A
				Clear Space?	N/A
			N/A	Clear Space to XWalk (in)	N/A
			N/A	Any Obstruction?	N/A
				Obstruction Type	N/A
					N/A
			N/A	Storm Grate/Utility Hazard?	N/A

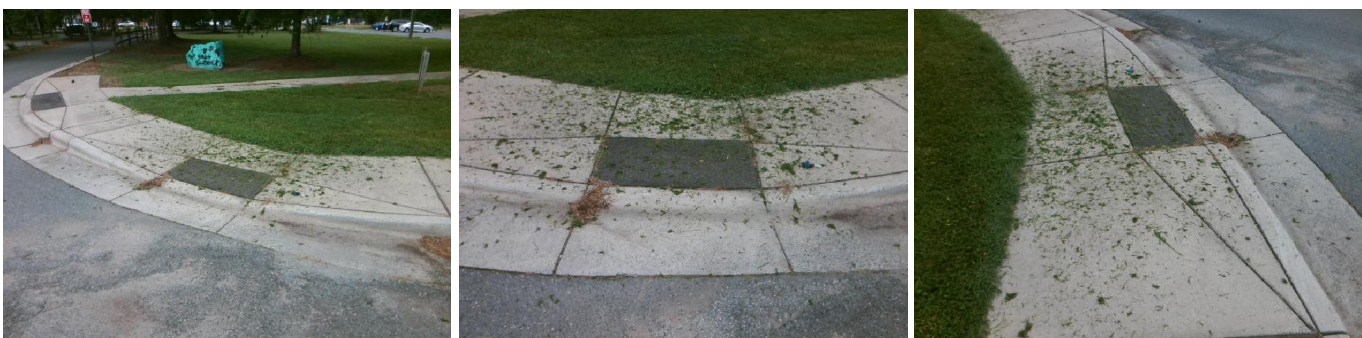
Storm Grate/Utility Type	N/A
			Yes	Surface Condition? (G/P)	Good
				Curb Slope (%)	21.6
