Access Compliance Report Public Rights-of-Way (Curb Ramps)

Intersection ID: N/A Main Street: ELEVATION_POINT_DR Cross Street: FLOURNOY_DR Location: SE

ADA ID: 4E56A0670C37 Ramp Type: Perp Initial Pass/Fail: Fail Overall Compliance: No Severity Score: 13.75

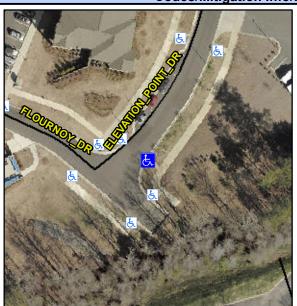
Compliance Description Data				liance Description	Data
N/A	Ramp Length (in)	82.5	No	Ramp Slope (%)	8.4
Yes	Ramp Width (in)	57.0	No	Ramp XSlope (%)	3.4
N/A	Flare Type LT	N/A	N/A	Flare Type RT	N/A
N/A	Flare Slope LT (%)	N/A	N/A	Flare Slope RT (%)	N/A
N/A	Flare Traversable LT?	N/A	N/A	Flare Traversable RT?	N/A
N/A	Landing Length (in)	N/A	N/A	DWS Provided?	N/A
N/A	Landing Width (in)	N/A	N/A	DWS Contrast?	N/A
N/A	Landing Slope (%)	N/A	N/A	DWS Length (in)	N/A
N/A	Landing X Slope (%)	N/A	N/A	DWS Full Width?	N/A
N/A	Landing Curb? (Y/N)	N/A	N/A	DWS Offset (in)	N/A
N/A	Shared Landing?	N/A			
N/A	Gutter Ponding?	N/A	N/A	Gutter Slope (%)	N/A
N/A	Gutter Lip Ht (in)	N/A	N/A	Gutter X Slope (%)	N/A
N/A	Painted X Walk1?	No	N/A	Painted X Walk2?	N/A
	X Walk 1 Direction	To NW		X Walk 2 Direction	N/A
N/A	X Walk 1 Width (in)	N/A	N/A	X Walk 2 Width (in)	N/A
	X Walk 1 Slope (%)	0.1		X Walk 2 Slope (%)	N/A
	X Walk 1 X Slope (%)	1.6		X Walk 2 X Slope (%)	N/A

N/A	Ramp inside XWalk1?	N/A	N/A	Ramp inside XWalk2?	N/A
	Road Slope (%)	N/A	N/A	Clear Space?	N/A
	Road X Slope (%)	N/A	N/A	Clear Space to XWalk (in)	N/A
N/A	Any Obstructions?	N/A	N/A	Storm Grate/Utility Hazard?	N/A
	Obstruction Type			Storm Grate/Utility Type	
		N/A			N/A
	ECOTOS CERCLAMENTALIA		Yes	Surface Condition? (G/P)	Good

Possible Solutions:	9			
Remove & Replace Entire Ramp.				
·	Y			
	N			
	N			
	1			
	1			
Surveyor Notes:	1			
N/A	1			
	1			
	1			
	1			
PROW/ADA:	1			
Not Found, R304.2.2, R304.5.3	N			
, , , , , , , , , , , , , , , , , , , ,	N			
	N
