Access Compliance Report

Public Rights-of-Way

(Curb Ramps)

Intersection ID: 2516	Main Street: ROCKY_FORD_CLUB_RD	Cross Street: EASTFIELD_RD	Location: W
ADA ID: 4E573A9E05B3	Ramp Type: Perp	Initial Pass/Fail: Fail	Overall Compliance: No
Codes/Mitigation Info/Possible Solution		Field Measurements/Component Compliance	
Severity Score: 8.75

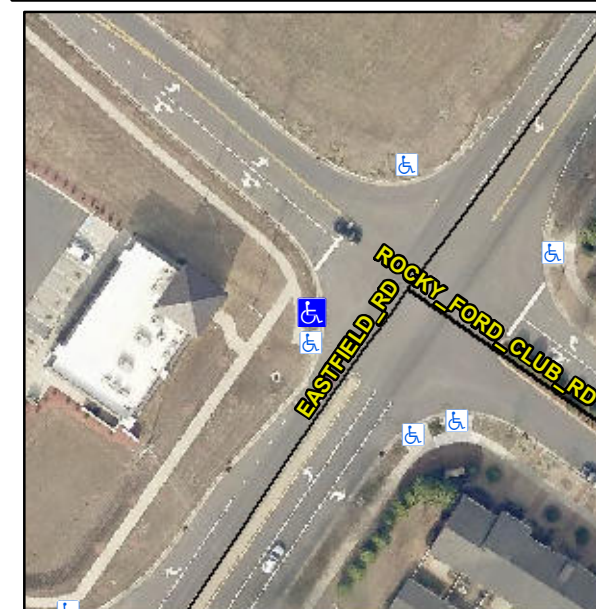
Compliance	Description	Data	Compliance	Description	Data
N/A	Ramp Length (in)	95.0	Yes	Ramp Slope (%)	7.7
No	Ramp Width (in)	46.5	Yes	Ramp XSlope (%)	0.9
N/A	Flare Type LT	N/A	N/A	Flare Type RT	N/A
N/A	Flare Slope LT (%)	N/A	N/A	Flare Slope RT (%)	N/A
N/A	Flare Traversable LT?	N/A	N/A	Flare Traversable RT?	N/A
N/A	Landing Length (in)	N/A	N/A	DWS Provided?	N/A
N/A	Landing Width (in)	N/A	N/A	DWS Contrast?	N/A
N/A	Landing Slope (%)	N/A	N/A	DWS Length (in)	N/A
N/A	Landing X Slope (%)	N/A	N/A	DWS Full Width?	N/A
N/A	Landing Curb? (Y/N)	N/A	N/A	DWS Offset (in)	N/A
N/A	Shared Landing?	N/A			
N/A	Gutter Ponding?	Yes	N/A	Gutter Slope (%)	N/A
N/A	Gutter Lip Ht (in)	N/A	N/A	Gutter X Slope (%)	N/A
N/A	Painted X Walk1?	No	N/A	Painted X Walk2?	N/A
	X Walk 1 Direction	To NE		X Walk 2 Direction	N/A
N/A	X Walk 1 Width (in)	N/A	N/A	X Walk 2 Width (in)	N/A
	X Walk 1 Slope (%)	1.3		X Walk 2 Slope (%)	N/A
	X Walk 1 X Slope (%)	0.3		X Walk 2 X Slope (%)	N/A

N/A	Ramp inside XWalk1?	N/A	N/A	Ramp inside XWalk2?	N/A
	Road Slope (%)	N/A	N/A	Clear Space?	N/A
	Road X Slope (%)	N/A	N/A	Clear Space to XWalk (in)	N/A
N/A	Any Obstructions?	N/A	N/A	Storm Grate/Utility Hazard?	N/A
	Obstruction Type			Storm Grate/Utility Type	
		N/A			N/A
		Yes		Surface Condition? (G/P)	Good

Possible Solutions:

Remove & Replace Entire Ramp.

PROW/ADA:

R304.5.1
