# Access Compliance Report

## Public Rights-of-Way

### (Curb Ramps)

Intersection ID: 13994	Main Street: E_3RD_ST	Cross Street: S_TORRENCE_ST	Location: NE
ADA ID: 4E5B8278DF38	Ramp Type: Perp	Initial Pass/Fail: Fail	Overall Compliance: No
Severity Score: 33.75			
Codes/Mitigation Info/Possible Solution		Field Measurements/Component Compliance

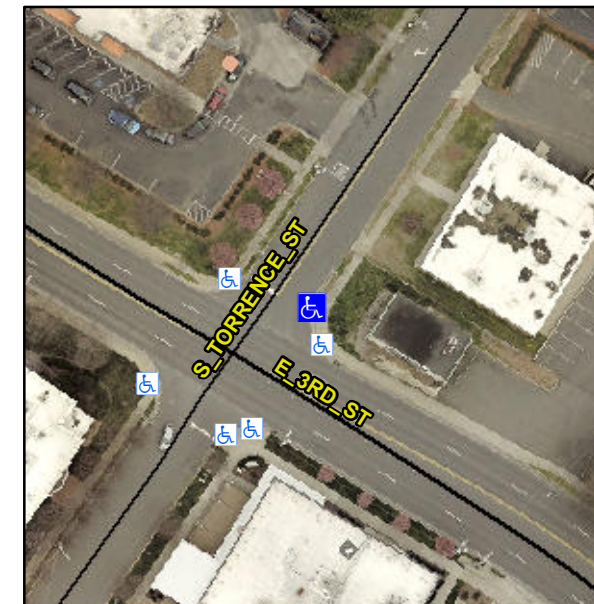
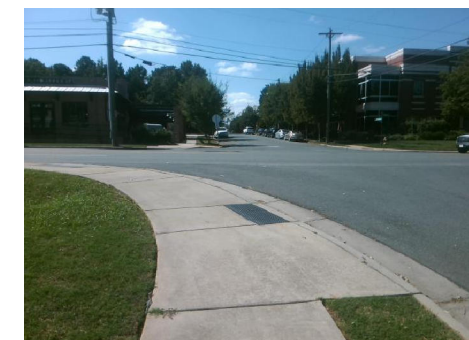
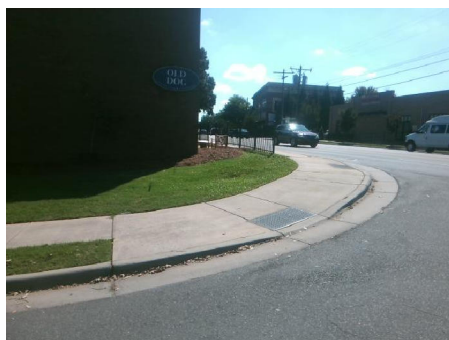
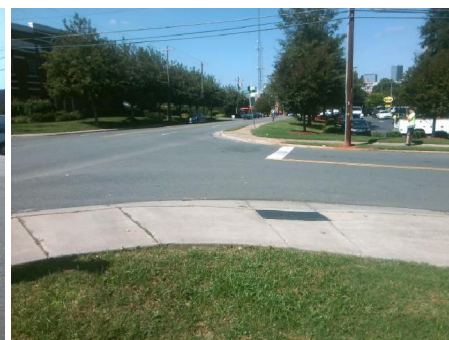
**Not Found, R304.5.1, R304.5.3**

Compliance	Description	Data	Compliance	Description	Data
N/A	Ramp Length (in)	81.0	Yes	Ramp Slope (%)	5.3
No	Ramp Width (in)	36.0	No	Ramp XSlope (%)	14.0
N/A	Flare Type LT	N/A	N/A	Flare Type RT	N/A
N/A	Flare Slope LT (%)	N/A	N/A	Flare Slope RT (%)	N/A
N/A	Flare Traversable LT?	N/A	N/A	Flare Traversable RT?	N/A
N/A	Landing Length (in)	N/A	N/A	DWS Provided?	N/A
N/A	Landing Width (in)	N/A	N/A	DWS Contrast?	N/A
N/A	Landing Slope (%)	N/A	N/A	DWS Length (in)	N/A
N/A	Landing X Slope (%)	N/A	N/A	DWS Full Width?	N/A
N/A	Landing Curb? (Y/N)	N/A	N/A	DWS Offset (in)	N/A
N/A	Shared Landing?	N/A			
N/A	Gutter Ponding?	N/A	N/A	Gutter Slope (%)	N/A
N/A	Gutter Lip Ht (in)	N/A	N/A	Gutter X Slope (%)	N/A
N/A	Painted X Walk1?	No	N/A	Painted X Walk2?	N/A
	X Walk 1 Direction	To NW		X Walk 2 Direction	N/A
N/A	X Walk 1 Width (in)	N/A	N/A	X Walk 2 Width (in)	N/A
	X Walk 1 Slope (%)	1.4		X Walk 2 Slope (%)	N/A
	X Walk 1 X Slope (%)	10.9		X Walk 2 X Slope (%)	N/A

N/A	Ramp inside XWalk1?	N/A	N/A	Ramp inside XWalk2?	N/A
	Road Slope (%)	N/A	N/A	Clear Space?	N/A
	Road X Slope (%)	N/A	N/A	Clear Space to XWalk (in)	N/A
N/A	Any Obstructions?	N/A	N/A	Storm Grate/Utility Hazard?	N/A
	Obstruction Type			Storm Grate/Utility Type	
		N/A			N/A
		Yes		Surface Condition? (G/P)	Good

**Remove & Replace Entire Ramp.**
