Access Compliance Report

Public Rights-of-Way

(Curb Ramps)

Intersection ID: N/A	Main Street: CRAIGHEAD_RD	Cross Street: N/A	Location: W
ADA ID: 4E5BFBAE8526	Ramp Type: ParaDiag	Initial Pass/Fail: Fail	Overall Compliance: No
			Severity Score: 13.75

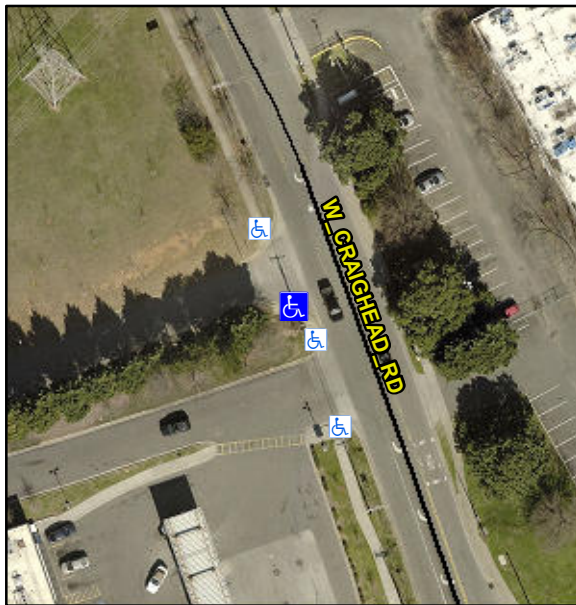
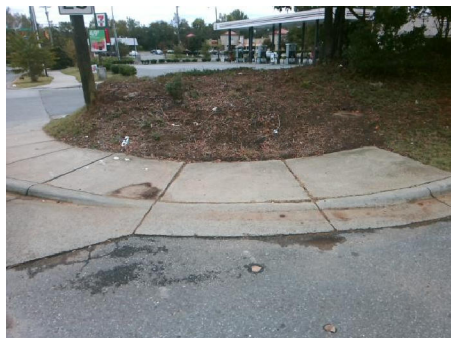
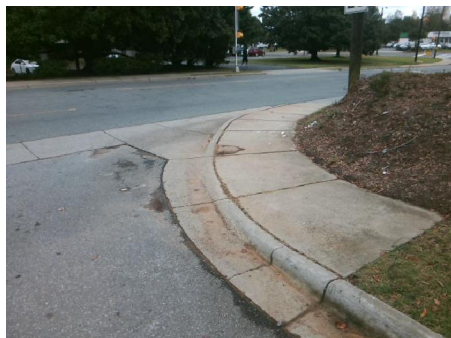
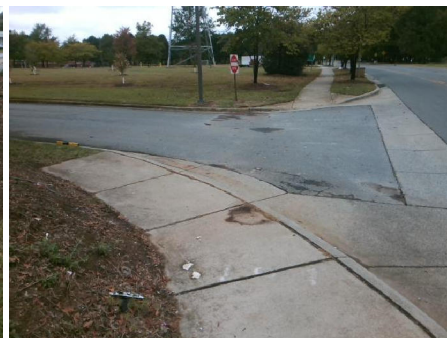
LT RP < 5%

R304.5.3, R304.3.2

Compliance	Description	Data	Compliance	Description	Data
N/A	Ramp Length LT (in)	49.0	N/A	Ramp Length RT (in)	62.0
Yes	Ramp Width LT (in)	60.0	Yes	Ramp Width RT (in)	60.0
Yes	Ramp Slope LT (%)	3.5	No	Ramp Slope RT (%)	9.3
No	Ramp XSlope LT (%)	2.2	Yes	Ramp XSlope RT (%)	1.9
N/A	Landing Length (in)	N/A	N/A	DWS Provided?	N/A
N/A	Landing Width (in)	N/A	N/A	DWS Contrast?	N/A
N/A	Landing Slope (%)	N/A	N/A	DWS Length (in)	N/A
N/A	Landing X Slope (%)	N/A	N/A	DWS Full Width?	N/A
N/A	Landing Curb? (Y/N)	N/A	N/A	DWS Offset (in)	N/A
N/A	Shared Landing?	N/A			
N/A	Gutter Ponding?	N/A	N/A	Gutter Slope (%)	N/A
N/A	Gutter Lip Ht (in)	N/A	N/A	Gutter X Slope (%)	N/A
N/A	Painted X Walk1?	No	N/A	Painted X Walk2?	No
	X Walk 1 Direction	To E		X Walk 2 Direction	To NW
N/A	X Walk 1 Width (in)	N/A	N/A	X Walk 2 Width (in)	N/A
	X Walk 1 Slope (%)	1.4		X Walk 2 Slope (%)	1.9
	X Walk 1 X Slope (%)	2.4		X Walk 2 X Slope (%)	1.0
N/A	Ramp inside XWalk1?	N/A	N/A	Ramp inside XWalk2?	N/A

Road Slope (%)	1.1	N/A	Clear Space?	N/A
	Road X Slope (%)	1.2	N/A	Clear Space to XWalk (in)	N/A
N/A	Any Obstructions?	N/A	N/A	Storm Grate/Utility Hazard?	N/A
	Obstruction Type			Storm Grate/Utility Type	
		N/A			N/A
			Yes	Surface Condition? (G/P)	Good
			N/A	Curb Slope (%)	2.8

Remove & Replace Curb Ramp With Two New Directional Ramps or Equivalent.
