Access Compliance Report

Public Rights-of-Way

(Curb Ramps)

Intersection ID: N/A	Main Street: E_STONEWALL_ST	Cross Street: S_COLLEGE_ST	Location: S
ADA ID: 4E5D427892BD	Ramp Type: Perp	Initial Pass/Fail: Fail	Overall Compliance: No
Codes/Mitigation Info/Possible Solution		Field Measurements/Component Compliance	
Severity Score: 13.75

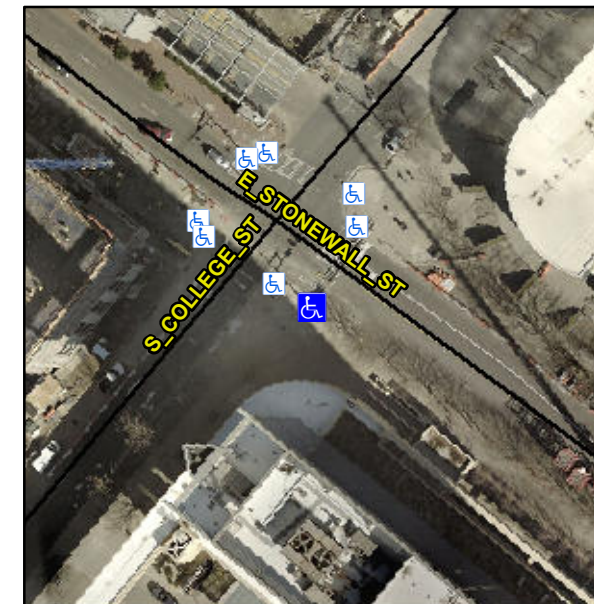
Not Found, R304.2.2, R304.5.3

Compliance	Description	Data	Compliance	Description	Data
N/A	Ramp Length (in)	48.0	No	Ramp Slope (%)	8.8
Yes	Ramp Width (in)	48.0	No	Ramp XSlope (%)	2.8
N/A	Flare Type LT	N/A	N/A	Flare Type RT	N/A
N/A	Flare Slope LT (%)	N/A	N/A	Flare Slope RT (%)	N/A
N/A	Flare Traversable LT?	No	N/A	Flare Traversable RT?	No
N/A	Landing Length (in)	N/A	N/A	DWS Provided?	N/A
N/A	Landing Width (in)	N/A	N/A	DWS Contrast?	N/A
N/A	Landing Slope (%)	N/A	N/A	DWS Length (in)	N/A
N/A	Landing X Slope (%)	N/A	N/A	DWS Full Width?	N/A
N/A	Landing Curb? (Y/N)	N/A	N/A	DWS Offset (in)	N/A
N/A	Shared Landing?	N/A			
N/A	Gutter Ponding?	N/A	N/A	Gutter Slope (%)	N/A
N/A	Gutter Lip Ht (in)	N/A	N/A	Gutter X Slope (%)	N/A
N/A	Painted X Walk1?	Yes	N/A	Painted X Walk2?	N/A
	X Walk 1 Direction	To NE		X Walk 2 Direction	N/A
N/A	X Walk 1 Width (in)	112.0	N/A	X Walk 2 Width (in)	N/A
	X Walk 1 Slope (%)	0.8		X Walk 2 Slope (%)	N/A
	X Walk 1 X Slope (%)	0.2		X Walk 2 X Slope (%)	N/A

N/A	Ramp inside XWalk1?	Yes	N/A	Ramp inside XWalk2?	N/A
	Road Slope (%)	N/A	N/A	Clear Space?	N/A
	Road X Slope (%)	N/A	N/A	Clear Space to XWalk (in)	N/A
N/A	Any Obstructions?	N/A	N/A	Storm Grate/Utility Hazard?	N/A
	Obstruction Type			Storm Grate/Utility Type	
		N/A			N/A
			Yes	Surface Condition? (G/P)	Good

Possible Solutions:

Remove & Replace Entire Ramp.
