| Intersection ID: 10021374 | Main Street: BLUE_CEDAR_LN | Cross Street: N/A | Location: | N |
| ADA ID: 4E6D1403CD16 | Ramp Type: PerpDiag | Initial Pass/Fail: Fail | Overall Compliance: No | Severity Score: 13.75 |

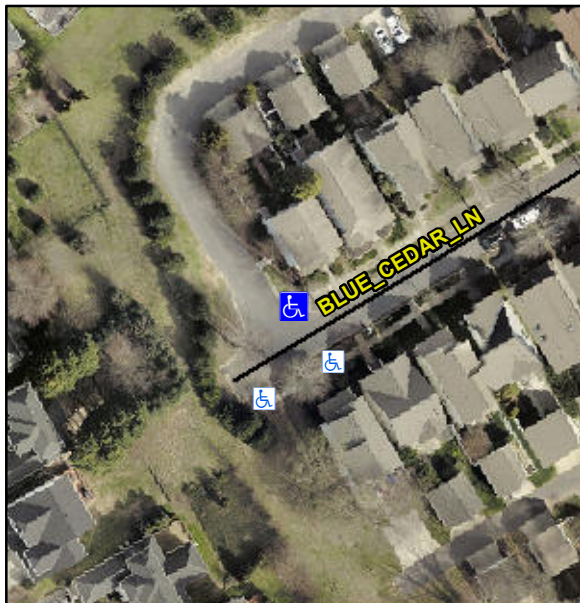
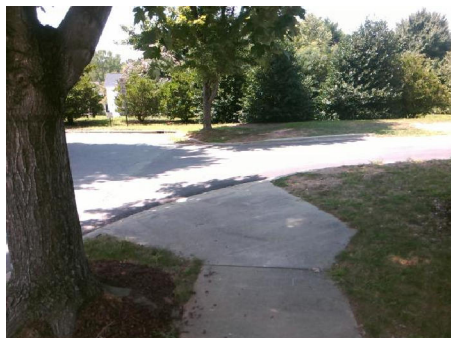
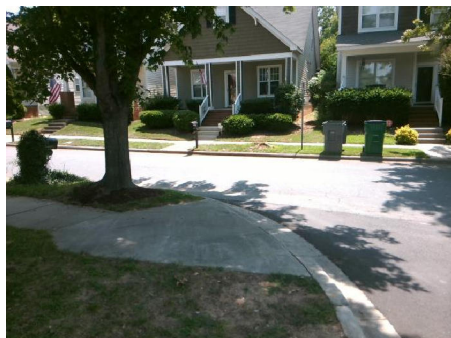
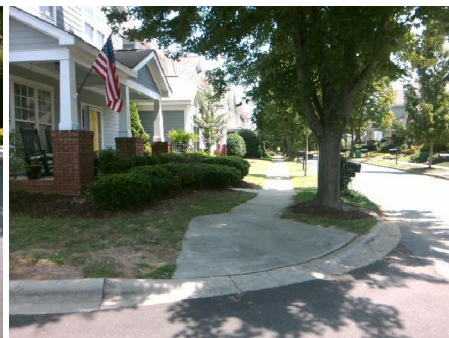
| Codes/Mitigation Info/Possible Solution | | | Field Measurements/Component Compliance | | | | | |
|---|---|---|---|---|---|---|---|---|
| | Remove & Replace Curb Ramp With Two New Directional Ramps or Equivalent. | | N/A | Ramp Length (in) | 107.0 | No | Ramp Slope (%) | 8.8 |
| | | | Yes | Ramp Width (in) | 48.0 | No | Ramp XSlope (%) | 3.3 |
| PROW/ADA: | | Not Found, R304.2.2, R304.5.3 | N/A | Shared Landing? | N/A | N/A | | |

| Codes/Mitigation Info/Possible Solution | | | Field Measurements/Component Compliance | | | | | |
|---|---|---|---|---|---|---|---|---|
| | Possible Solutions: | | Compliance | Description | Data | Compliance | Description | Data |
