# Access Compliance Report

## Public Rights-of-Way

### (Curb Ramps)

| ADA ID: 4E7B9030C188 | Ramp Type: Directional1 | Initial Pass/Fail: Fail | Overall Compliance: No |

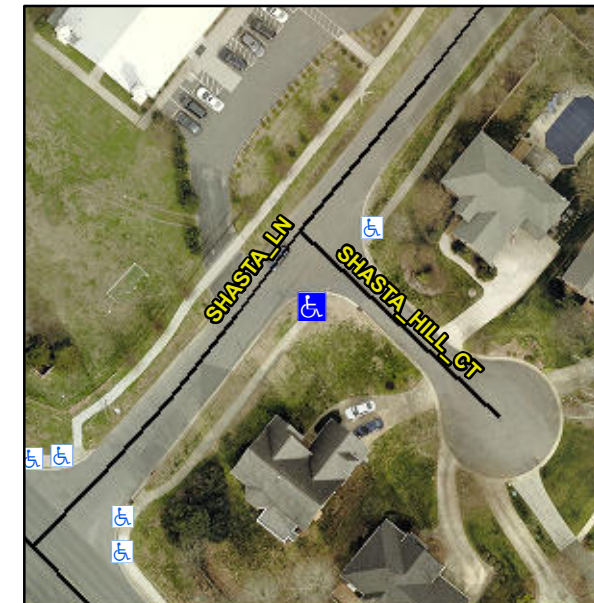
**R304.5.3**

| Compliance | Description | Data | Compliance | Description | Data |
|---|---|---|---|---|---|
| No | Ramp XSlope (%) | 5.5 | | | |

**Remove & Replace Entire Ramp.**

Total Cost: \$ 1600.00
