# Access Compliance Report

## Public Rights-of-Way

### (Curb Ramps)

| Intersection ID: 18018 | Main Street: GILMORE_DR | Cross Street: INWOOD_DR | Location: NW |

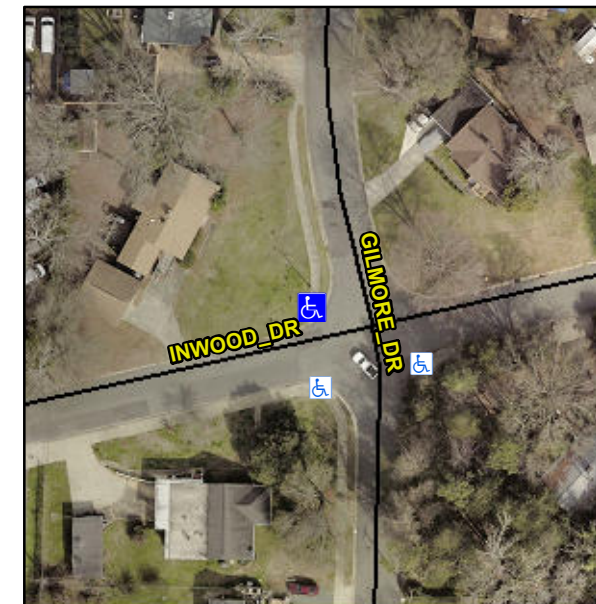
**Not Found, R304.2.1, R305.1.4, R305.2, R302.7.2**

| Compliance | Description | Data | Compliance | Description | Data |
|---|---|---|---|---|---|
| No | Landing Length (in) | 19.0 | Yes | DWS Provided? | Yes |
| Yes | Landing X Slope (%) | 2.1 | No | DWS Full Width? | No |
| N/A | Shared Landing? | No | No | DWS Offset RT (in) | 4.5 |
| No | Gutter Lip Ht (in) | 0.3 | Yes | Gutter X Slope (%) | 2.5 |

**Remove & Replace Entire Ramp.**
