# Access Compliance Report

## Public Rights-of-Way

### (Curb Ramps)

Intersection ID: 8910	Main Street: KAY_ST	Cross Street: NEWCASTLE_ST	Location: SE
ADA ID: 4E8A8C161299	Ramp Type: Perp	Initial Pass/Fail: Fail	Overall Compliance: No
Severity Score: 22.5			
Codes/Mitigation Info/Possible Solution		Field Measurements/Component Compliance

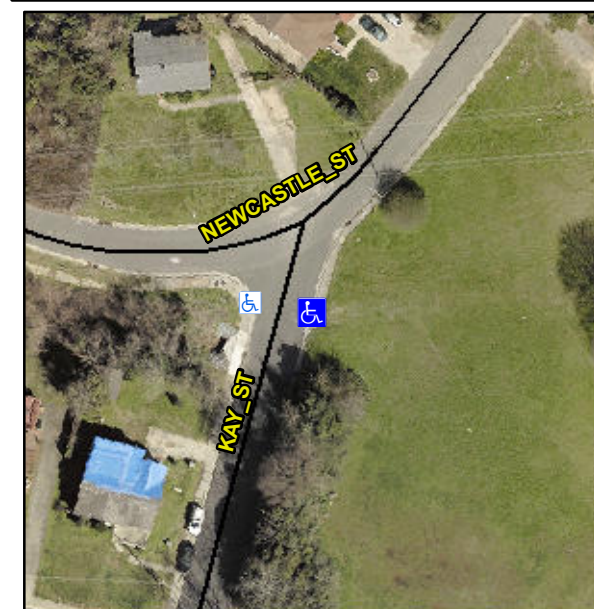
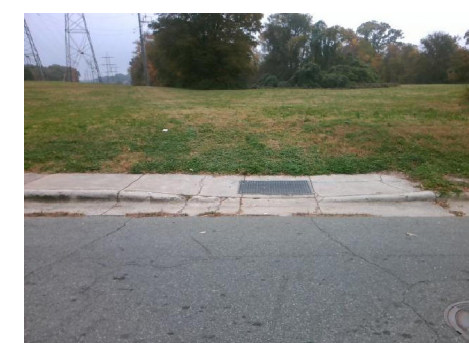
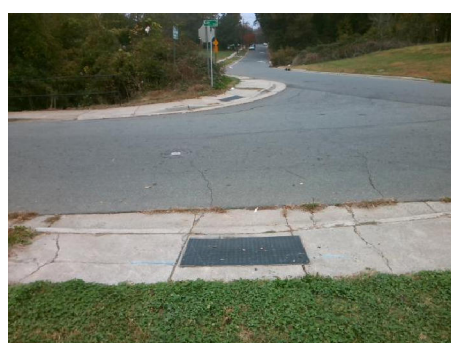
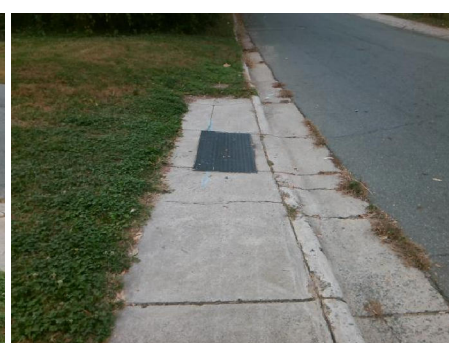
**Not Found, R304.5.1, R304.2.2**

Compliance	Description	Data	Compliance	Description	Data
N/A	Ramp Length (in)	47.0	No	Ramp Slope (%)	8.5
No	Ramp Width (in)	47.0	Yes	Ramp XSlope (%)	2.9
N/A	Flare Type LT	N/A	N/A	Flare Type RT	N/A
N/A	Flare Slope LT (%)	N/A	N/A	Flare Slope RT (%)	N/A
N/A	Flare Traversable LT?	N/A	N/A	Flare Traversable RT?	N/A
N/A	Landing Length (in)	N/A	N/A	DWS Provided?	N/A
N/A	Landing Width (in)	N/A	N/A	DWS Contrast?	N/A
N/A	Landing Slope (%)	N/A	N/A	DWS Length (in)	N/A
N/A	Landing X Slope (%)	N/A	N/A	DWS Full Width?	N/A
N/A	Landing Curb? (Y/N)	N/A	N/A	DWS Offset (in)	N/A
N/A	Shared Landing?	N/A			
N/A	Gutter Ponding?	N/A	N/A	Gutter Slope (%)	N/A
N/A	Gutter Lip Ht (in)	0.5	N/A	Gutter X Slope (%)	N/A
N/A	Painted X Walk1?	No	N/A	Painted X Walk2?	N/A
	X Walk 1 Direction	To W		X Walk 2 Direction	N/A
N/A	X Walk 1 Width (in)	N/A	N/A	X Walk 2 Width (in)	N/A
	X Walk 1 Slope (%)	7.4		X Walk 2 Slope (%)	N/A
	X Walk 1 X Slope (%)	3.2		X Walk 2 X Slope (%)	N/A

N/A	Ramp inside XWalk1?	N/A	N/A	Ramp inside XWalk2?	N/A
	Road Slope (%)	N/A	N/A	Clear Space?	N/A
	Road X Slope (%)	N/A	N/A	Clear Space to XWalk (in)	N/A
N/A	Any Obstructions?	N/A	N/A	Storm Grate/Utility Hazard?	N/A
	Obstruction Type			Storm Grate/Utility Type	
		N/A			N/A
			Yes	Surface Condition? (G/P)	Good

Possible Solutions:

**Remove & Replace Entire Ramp.**
