# Access Compliance Report

## Public Rights-of-Way

### (Curb Ramps)

| Intersection ID: 44081 | Main Street: FOREST_RUN_LN | Cross Street: WESTMILL_LN | Location: NE |

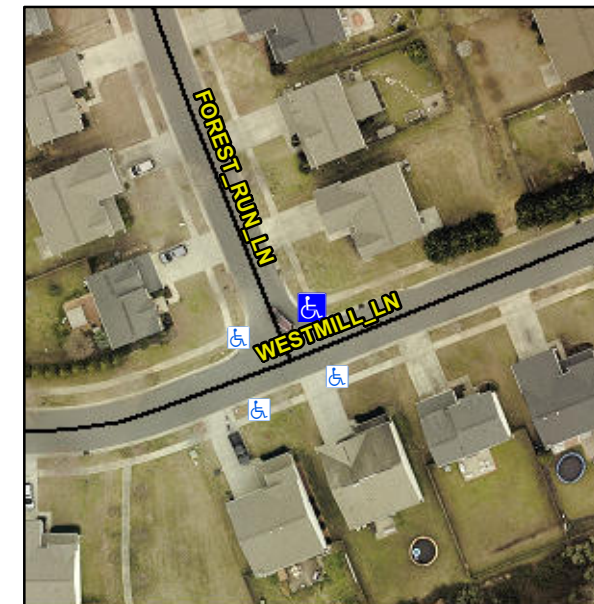
| ADA ID: 4E8F220196D3 | Ramp Type: BlendTrans1 | Initial Pass/Fail: Fail | Overall Compliance: No |
| Severity Score: 35 | | | |

**GTR GAP 7.0**

**Not Found, R304.5.1**

| Compliance | Description | Data | Compliance | Description | Data |
|---|---|---|---|---|---|
| No | Ramp Width (in) | 25.0 | Yes | BlendTrans XSlope (%) | 0.8 |
| N/A | Gutter Lip Ht (in) | 1.5 | N/A | Gutter X Slope (%) | N/A |

**Remove & Replace Curb Ramp With Two New Directional Ramps or Equivalent.**

Total Cost: \$ 3200.00
