Access Compliance Report Public Rights-of-Way (Curb Ramps)

Intersection ID: 52518Main Street:FRANKLIN_MEADOWS_DRCross Street:WEDDINGTON_RDLocation:NEADA ID: 4E8F67FDBB6DRamp Type:PerpInitial Pass/Fail:FailOverall Compliance:NoSeverity Score:13.75

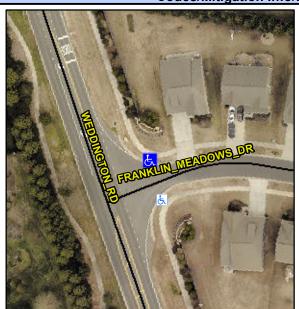
Field Measurements/Component Compliance								
Comp	liance Description	Data	Comp	liance	Description	Data		
N/A	Ramp Length (in)	66.0	No	Ramp	Slope (%)	9.5		
Yes	Ramp Width (in)	61.0	No	Ramp	XSlope (%)	2.8		
N/A	Flare Type LT	N/A	N/A	Flare	Type RT	N/A		
N/A	Flare Slope LT (%)	N/A	N/A	Flare	Slope RT (%)	N/A		
N/A	Flare Traversable LT?	N/A	N/A	Flare	Traversable RT?	N/A		
N/A	Landing Length (in)	N/A	N/A	DWS	Provided?	N/A		
N/A	Landing Width (in)	N/A	N/A	DWS	Contrast?	N/A		
N/A	Landing Slope (%)	N/A	N/A	DWS	Length (in)	N/A		
N/A	Landing X Slope (%)	N/A	N/A	DWS	Full Width?	N/A		
N/A	Landing Curb? (Y/N)	N/A	N/A	DWS	Offset (in)	N/A		
N/A	Shared Landing?	N/A						
N/A	Gutter Ponding?	N/A	N/A	Gutte	r Slope (%)	N/A		
N/A	Gutter Lip Ht (in)	N/A	N/A	Gutte	r X Slope (%)	N/A		
N/A	Painted X Walk1?	No	N/A	Paint	ed X Walk2?	N/A		
	X Walk 1 Direction	To S		X Wa	lk 2 Direction	N/A		
N/A	X Walk 1 Width (in)	N/A	N/A	X Wa	lk 2 Width (in)	N/A

X Walk 1 Slope (%)	1.4		X Wa	lk 2 Slope (%)	N/A		
	X Walk 1 X Slope (%)	3.2		X Wa	lk 2 X Slope (%)	N/A		
N/A	Ramp inside XWalk1?	N/A	N/A	Ramp	inside XWalk2?	N/A		
	Road Slope (%)	N/A	N/A	Clear	Space?	N/A		
	Road X Slope (%)	N/A	N/A	Clear	Space to XWalk (in)	N/A		
N/A	Any Obstructions?	N/A	N/A	Storm	Grate/Utility Hazard?	N/A		
	Obstruction Type			Storm	Grate/Utility Type			
		N/A				N/A		
			Yes	Surfa	ce Condition? (G/P)	Good		
100000000

Possible Solutions:							
Remove & Replace Entire Ramp.							
Surveyor Notes:							
N/A							
PROW/ADA:							
Not Found, R304.2.2, R304.5.3							
J

1850.00
