# Access Compliance Report

## Public Rights-of-Way

### (Curb Ramps)

| Intersection ID: 29262 | Main Street: SPARROW_VALLEY_WY | Cross Street: POINTER_RIDGE_DR | Location: S |

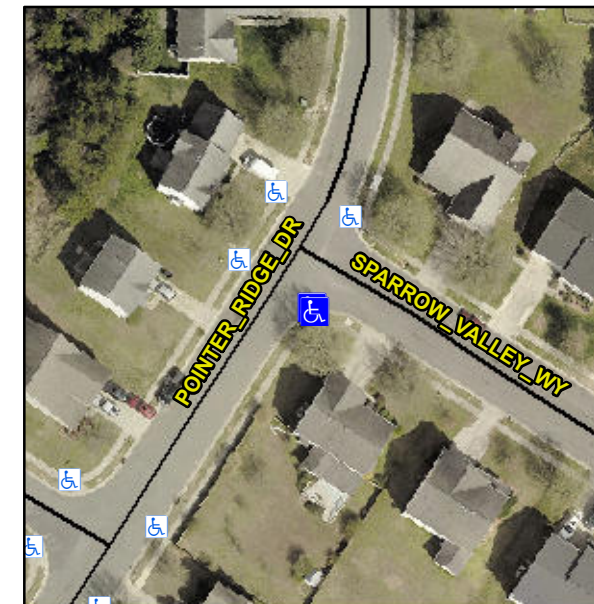
| ADA ID: 4E996A33356A | Ramp Type: PerpDiag | Initial Pass/Fail: Fail | Overall Compliance: No |
| Severity Score: 33.75 | | | |

**Not Found, R304.5.1, R304.5.3**

| Compliance | Description | Data | Compliance | Description | Data |
|---|---|---|---|---|---|
| N/A | Ramp Length (in) | 46.0 | Yes | Ramp Slope (%) | 6.8 |
| No | Ramp Width (in) | 44.0 | No | Ramp XSlope (%) | 7.5 |

**Remove & Replace Curb Ramp With Two New Directional Ramps or Equivalent.**

Total Cost: \$ 3200.00
