Access Compliance Report

Public Rights-of-Way

(Curb Ramps)

Intersection ID: 18584	Main Street: NOTTINGHAM_DR	Cross Street: ROBINHOOD_RD	Location:	W
ADA ID: 4EA5437D65AB	Ramp Type: BlendTrans1	Initial Pass/Fail: Fail	Overall Compliance: No	Severity Score: 10

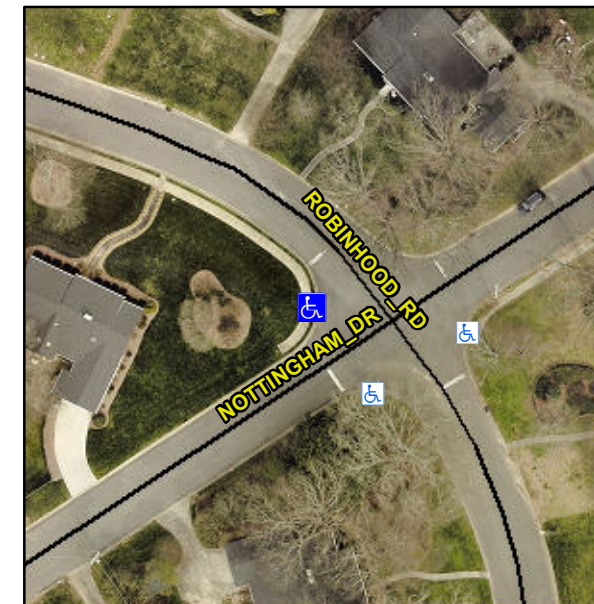
Not Found, R304.5.1, R304.5.3

Compliance	Description	Data	Compliance	Description	Data
N/A	Ramp Length (in)	28.0	Yes	BlendTrans Slope (%)	2.5
No	Ramp Width (in)	44.0	No	BlendTrans XSlope (%)	4.0
N/A	Flare Type LT	N/A	N/A	Flare Type RT	N/A
N/A	Flare Slope LT (%)	N/A	N/A	Flare Slope RT (%)	N/A
N/A	Flare Traversable LT?	N/A	N/A	Flare Traversable RT?	N/A
N/A	Landing Length (in)	N/A	N/A	DWS Provided?	N/A
N/A	Landing Width (in)	N/A	N/A	DWS Contrast?	N/A
N/A	Landing Slope (%)	N/A	N/A	DWS Length (in)	N/A
N/A	Landing X Slope (%)	N/A	N/A	DWS Full Width?	N/A
N/A	Landing Curb? (Y/N)	N/A	N/A	DWS Offset (in)	N/A
N/A	Shared Landing?	N/A			
N/A	Gutter Ponding?	N/A	N/A	Gutter Slope (%)	N/A
N/A	Gutter Lip Ht (in)	N/A	N/A	Gutter X Slope (%)	N/A
N/A	Painted X Walk1?	No	N/A	Painted X Walk2?	No
	X Walk 1 Direction	To SE		X Walk 2 Direction	To NE
	X Walk 1 Width (in)	N/A		X Walk 2 Width (in)	N/A
	X Walk 1 Slope (%)	6.8		X Walk 2 Slope (%)	2.5
	X Walk 1 X Slope (%)	1.1		X Walk 2 X Slope (%)	7.1

N/A	Ramp inside XWalk1?	N/A	N/A	Ramp inside XWalk2?	N/A
	Road Slope (%)	5.3		Clear Space?	N/A
	Road X Slope (%)	5.9	N/A	Clear Space to XWalk (in)	N/A
N/A	Any Obstructions?	N/A	N/A	Storm Grate/Utility Hazard?	N/A
	Obstruction Type			Storm Grate/Utility Type	
		N/A			N/A
			Yes	Surface Condition? (G/P)	Good
			No	Curb Slope (%)	10.1

Remove & Replace Curb Ramp With Two New Directional Ramps or Equivalent.
