Access Compliance Report

Public Rights-of-Way

(Curb Ramps)

Intersection ID: 3062	Main Street: LOGANVILLE_DR	Cross Street: BENFIELD_RD	Location: SE
ADA ID: 4EA572E8F268	Ramp Type: Para	Initial Pass/Fail: Fail	Overall Compliance: No
Codes/Mitigation Info/Possible Solution		Field Measurements/Component Compliance	
Severity Score: 13.75

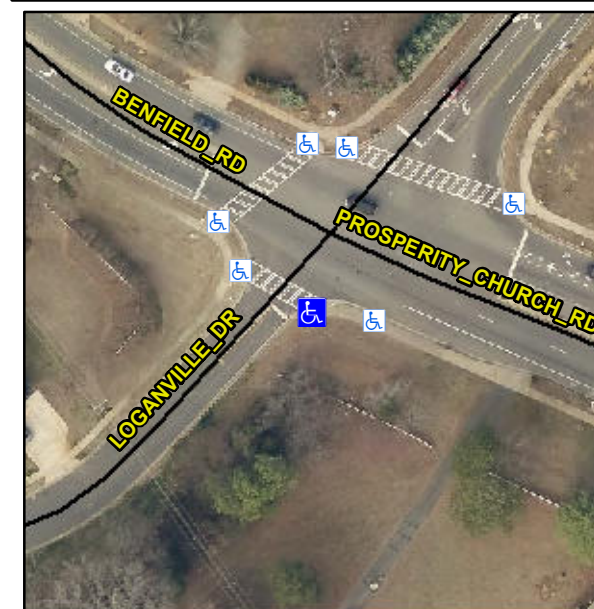
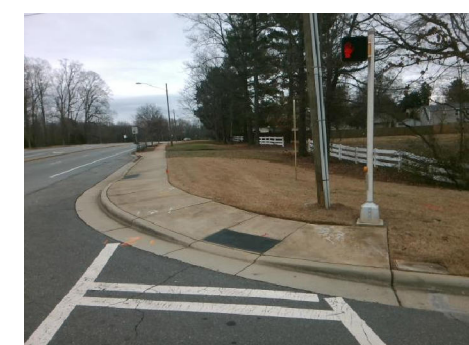
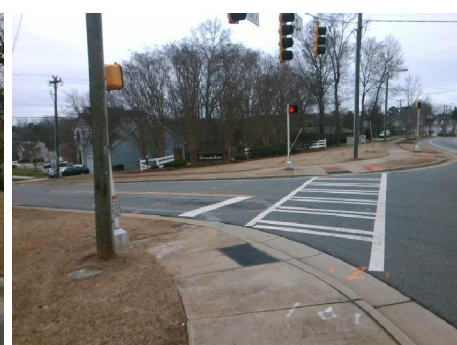
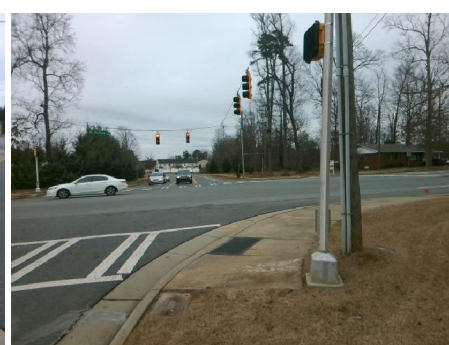
RT RP < 5%

Compliance	Description	Data	Compliance	Description	Data
N/A	Ramp Length LT (in)	60.0	N/A	Ramp Length RT (in)	56.0
Yes	Ramp Width LT (in)	72.0	Yes	Ramp Width RT (in)	72.0
No	Ramp Slope LT (%)	11.3	Yes	Ramp Slope RT (%)	0.7
No	Ramp XSlope LT (%)	2.1	No	Ramp XSlope RT (%)	2.3
N/A	Landing Length (in)	N/A	N/A	DWS Provided?	N/A
N/A	Landing Width (in)	N/A	N/A	DWS Contrast?	N/A
N/A	Landing Slope (%)	N/A	N/A	DWS Length (in)	N/A
N/A	Landing X Slope (%)	N/A	N/A	DWS Full Width?	N/A
N/A	Landing Curb? (Y/N)	N/A	N/A	DWS Offset (in)	N/A
N/A	Shared Landing?	N/A			
N/A	Gutter Ponding?	N/A	N/A	Gutter Slope (%)	N/A
N/A	Gutter Lip Ht (in)	N/A	N/A	Gutter X Slope (%)	N/A
N/A	Painted X Walk1?	Yes	N/A	Painted X Walk2?	N/A
	X Walk 1 Direction	To NW		X Walk 2 Direction	N/A
N/A	X Walk 1 Width (in)	108.0	N/A	X Walk 2 Width (in)	N/A
	X Walk 1 Slope (%)	0.1		X Walk 2 Slope (%)	N/A
	X Walk 1 X Slope (%)	6.6		X Walk 2 X Slope (%)	N/A
N/A	Ramp inside XWalk1?	Yes	N/A	Ramp inside XWalk2?	N/A

Road Slope (%)	N/A	N/A	Clear Space?	N/A
	Road X Slope (%)	N/A	N/A	Clear Space to XWalk (in)	N/A
N/A	Any Obstructions?	N/A	N/A	Storm Grate/Utility Hazard?	N/A
	Obstruction Type			Storm Grate/Utility Type	
		N/A			N/A
			Yes	Surface Condition? (G/P)	Good
			N/A	Curb Slope (%)	2.4

Remove & Replace Entire Ramp.

R304.3.2, R304.5.3
