# Access Compliance Report

## Public Rights-of-Way

### (Curb Ramps)

Intersection ID: 54260	Main Street: BALLANTYNE_COMMONS_PY	Cross Street: BLACK_FOREST_LN	Location: NW
ADA ID: 4EA8CC2D83B2	Ramp Type: Perp	Initial Pass/Fail: Fail	Overall Compliance: No
Severity Score: 10			
Codes/Mitigation Info/Possible Solution		Field Measurements/Component Compliance

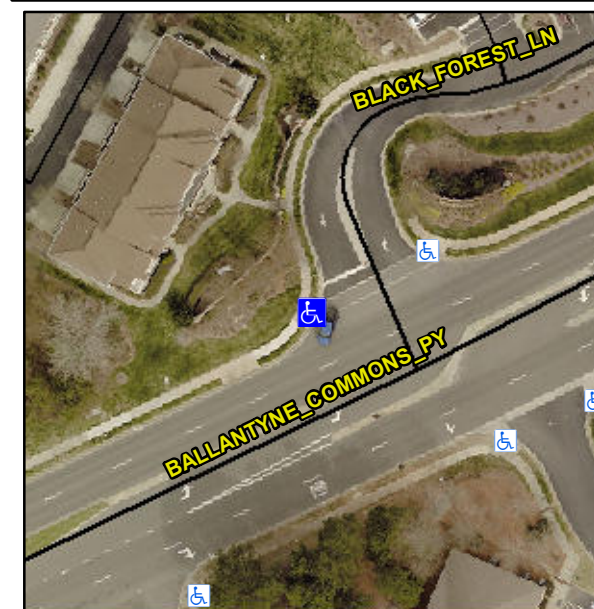
**Not Found, R304.5.1, R304.5.3**

Compliance	Description	Data	Compliance	Description	Data
N/A	Ramp Length (in)	108.0	Yes	Ramp Slope (%)	7.8
No	Ramp Width (in)	38.5	No	Ramp XSlope (%)	5.0
N/A	Flare Type LT	N/A	N/A	Flare Type RT	N/A
N/A	Flare Slope LT (%)	N/A	N/A	Flare Slope RT (%)	N/A
N/A	Flare Traversable LT?	N/A	N/A	Flare Traversable RT?	N/A
N/A	Landing Length (in)	N/A	N/A	DWS Provided?	N/A
N/A	Landing Width (in)	N/A	N/A	DWS Contrast?	N/A
N/A	Landing Slope (%)	N/A	N/A	DWS Length (in)	N/A
N/A	Landing X Slope (%)	N/A	N/A	DWS Full Width?	N/A
N/A	Landing Curb? (Y/N)	N/A	N/A	DWS Offset (in)	N/A
N/A	Shared Landing?	N/A			
N/A	Gutter Ponding?	N/A	N/A	Gutter Slope (%)	N/A
N/A	Gutter Lip Ht (in)	N/A	N/A	Gutter X Slope (%)	N/A
N/A	Painted X Walk1?	Yes	N/A	Painted X Walk2?	N/A
	X Walk 1 Direction	To NE		X Walk 2 Direction	N/A
N/A	X Walk 1 Width (in)	95.0	N/A	X Walk 2 Width (in)	N/A
	X Walk 1 Slope (%)	3.7		X Walk 2 Slope (%)	N/A
	X Walk 1 X Slope (%)	1.7		X Walk 2 X Slope (%)	N/A

**Remove & Replace Entire Ramp.**
