Access Compliance Report

Public Rights-of-Way

(Curb Ramps)

Intersection ID: 9709	Main Street: PARK_LN	Cross Street: TUCKASEEGEE_RD	Location: W
ADA ID: 4EABF1235665	Ramp Type: BlendTrans2	Initial Pass/Fail: Fail	Overall Compliance: No
Severity Score: 10			
Codes/Mitigation Info/Possible Solution		Field Measurements/Component Compliance

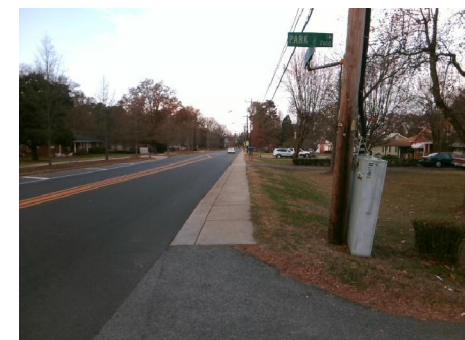
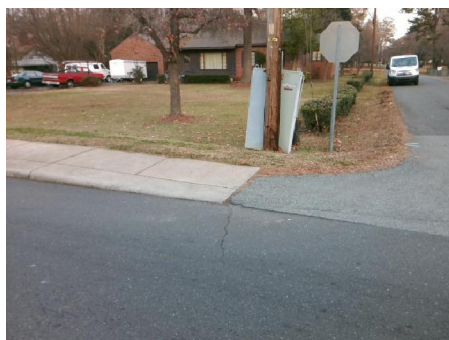
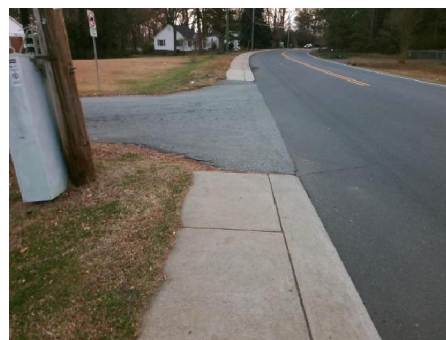
GTR GAP 2.0

Compliance	Description	Data	Compliance	Description	Data
N/A	Ramp Length (in)	60.0	Yes	BlendTrans Slope (%)	1.0
No	Ramp Width (in)	37.5	No	BlendTrans XSlope (%)	4.7
N/A	Flare Type LT	N/A	N/A	Flare Type RT	N/A
N/A	Flare Slope LT (%)	N/A	N/A	Flare Slope RT (%)	N/A
N/A	Flare Traversable LT?	N/A	N/A	Flare Traversable RT?	N/A
N/A	Landing Length (in)	N/A	N/A	DWS Provided?	N/A
N/A	Landing Width (in)	N/A	N/A	DWS Contrast?	N/A
N/A	Landing Slope (%)	N/A	N/A	DWS Length (in)	N/A
N/A	Landing X Slope (%)	N/A	N/A	DWS Full Width?	N/A
N/A	Landing Curb? (Y/N)	N/A	N/A	DWS Offset (in)	N/A
N/A	Shared Landing?	N/A			
N/A	Gutter Ponding?	N/A	N/A	Gutter Slope (%)	N/A
N/A	Gutter Lip Ht (in)	N/A	N/A	Gutter X Slope (%)	N/A
N/A	Painted X Walk1?	No	N/A	Painted X Walk2?	N/A
	X Walk 1 Direction	To E		X Walk 2 Direction	N/A
	X Walk 1 Width (in)	N/A		X Walk 2 Width (in)	N/A
	X Walk 1 Slope (%)	2.2		X Walk 2 Slope (%)	N/A
	X Walk 1 X Slope (%)	3.0		X Walk 2 X Slope (%)	N/A

N/A	Ramp inside XWalk1?	N/A	N/A	Ramp inside XWalk2?	N/A
	Road Slope (%)	3.0		Clear Space?	N/A
	Road X Slope (%)	2.2	N/A	Clear Space to XWalk (in)	N/A
N/A	Any Obstructions?	N/A	N/A	Storm Grate/Utility Hazard?	N/A
	Obstruction Type			Storm Grate/Utility Type	
		N/A			N/A
			Yes	Surface Condition? (G/P)	Good
			N/A	Curb Slope (%)	0.1

Possible Solutions:

Remove & Replace Curb Ramp With Two New Directional Ramps or Equivalent.
