Access Compliance Report

Public Rights-of-Way

(Curb Ramps)

Intersection ID: 31227	Main Street: CLACKWYCK_LN	Cross Street: HEADQUARTERS_FARM_RD	Location:	N
ADA ID: 4EBE25484F82	Ramp Type: Perp	Initial Pass/Fail: Fail	Overall Compliance: No	Severity Score: 18.75
Codes/Mitigation Info/Possible Solution		Field Measurements/Component Compliance

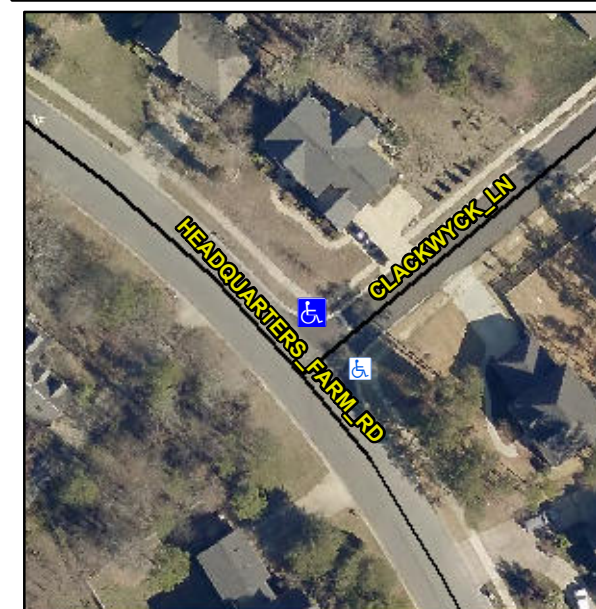
Not Found, R304.5.1, R304.5.3

Compliance	Description	Data	Compliance	Description	Data
N/A	Ramp Length (in)	62.0	Yes	Ramp Slope (%)	5.1
No	Ramp Width (in)	33.0	No	Ramp XSlope (%)	2.2
N/A	Flare Type LT	N/A	N/A	Flare Type RT	N/A
N/A	Flare Slope LT (%)	N/A	N/A	Flare Slope RT (%)	N/A
N/A	Flare Traversable LT?	N/A	N/A	Flare Traversable RT?	N/A
N/A	Landing Length (in)	N/A	N/A	DWS Provided?	N/A
N/A	Landing Width (in)	N/A	N/A	DWS Contrast?	N/A
N/A	Landing Slope (%)	N/A	N/A	DWS Length (in)	N/A
N/A	Landing X Slope (%)	N/A	N/A	DWS Full Width?	N/A
N/A	Landing Curb? (Y/N)	N/A	N/A	DWS Offset (in)	N/A
N/A	Shared Landing?	N/A			
N/A	Gutter Ponding?	N/A	N/A	Gutter Slope (%)	N/A
N/A	Gutter Lip Ht (in)	N/A	N/A	Gutter X Slope (%)	N/A
N/A	Painted X Walk1?	No	N/A	Painted X Walk2?	N/A
	X Walk 1 Direction	To SE		X Walk 2 Direction	N/A
N/A	X Walk 1 Width (in)	N/A	N/A	X Walk 2 Width (in)	N/A
	X Walk 1 Slope (%)	5.6		X Walk 2 Slope (%)	N/A
	X Walk 1 X Slope (%)	1.1		X Walk 2 X Slope (%)	N/A

Remove & Replace Entire Ramp.

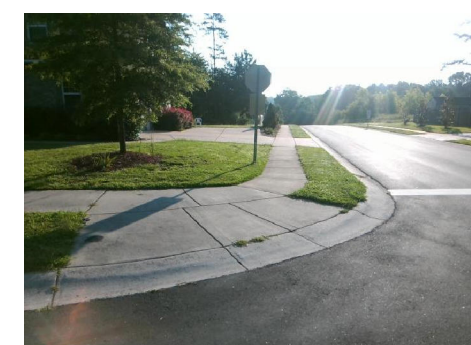
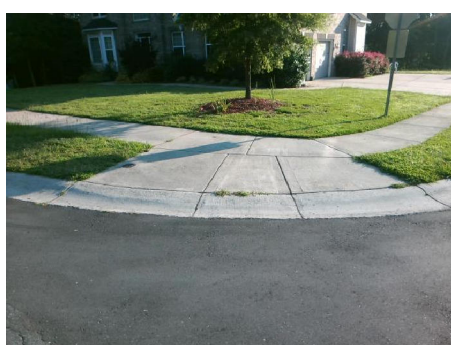
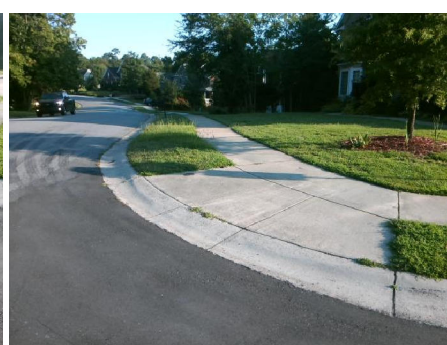
N/A	Ramp inside XWalk1?	N/A	N/A	Ramp inside XWalk2?	N/A
	Road Slope (%)	N/A	N/A	Clear Space?	N/A
	Road X Slope (%)	N/A	N/A	Clear Space to XWalk (in)	N/A
N/A	Any Obstructions?	N/A	N/A	Storm Grate/Utility Hazard?	N/A
	Obstruction Type			Storm Grate/Utility Type	
		N/A			N/A
			Yes	Surface Condition? (G/P)	Good
