# Access Compliance Report

## Public Rights-of-Way

### (Curb Ramps)

Intersection ID: 10035338	Main Street: RAIL_CROSSING_LN	Cross Street: N/A	Location: NW
ADA ID: 4EC59CF17508	Ramp Type: Perp	Initial Pass/Fail: Fail	Overall Compliance: No
		Severity Score: 25

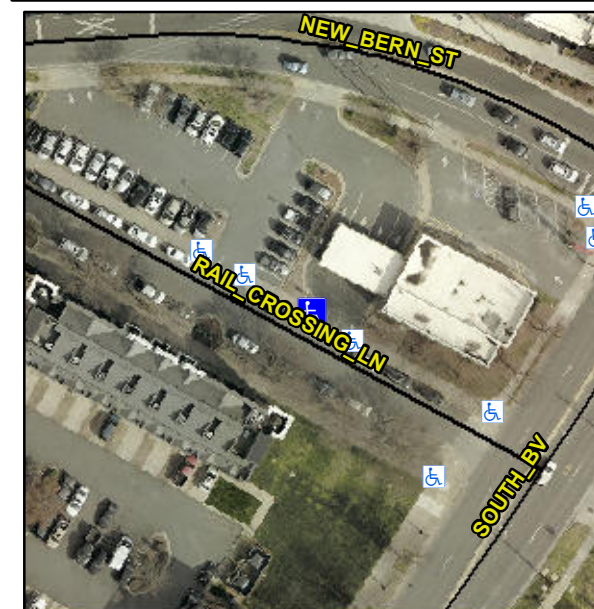
**Not Found, R304.5.3**

Compliance	Description	Data	Compliance	Description	Data
N/A	Ramp Length (in)	56.0	Yes	Ramp Slope (%)	6.8
Yes	Ramp Width (in)	54.0	No	Ramp XSlope (%)	11.2
N/A	Flare Type LT	N/A	N/A	Flare Type RT	N/A
N/A	Flare Slope LT (%)	N/A	N/A	Flare Slope RT (%)	N/A
N/A	Flare Traversable LT?	N/A	N/A	Flare Traversable RT?	N/A
N/A	Landing Length (in)	N/A	N/A	DWS Provided?	N/A
N/A	Landing Width (in)	N/A	N/A	DWS Contrast?	N/A
N/A	Landing Slope (%)	N/A	N/A	DWS Length (in)	N/A
N/A	Landing X Slope (%)	N/A	N/A	DWS Full Width?	N/A
N/A	Landing Curb? (Y/N)	N/A	N/A	DWS Offset (in)	N/A
N/A	Shared Landing?	N/A			
N/A	Gutter Ponding?	N/A	N/A	Gutter Slope (%)	N/A
N/A	Gutter Lip Ht (in)	N/A	N/A	Gutter X Slope (%)	N/A
N/A	Painted X Walk1?	No	N/A	Painted X Walk2?	N/A
	X Walk 1 Direction	To SE		X Walk 2 Direction	N/A
N/A	X Walk 1 Width (in)	N/A	N/A	X Walk 2 Width (in)	N/A
	X Walk 1 Slope (%)	2.2		X Walk 2 Slope (%)	N/A
	X Walk 1 X Slope (%)	7.3		X Walk 2 X Slope (%)	N/A

N/A	Ramp inside XWalk1?	N/A	N/A	Ramp inside XWalk2?	N/A
	Road Slope (%)	N/A	N/A	Clear Space?	N/A
	Road X Slope (%)	N/A	N/A	Clear Space to XWalk (in)	N/A
N/A	Any Obstructions?	N/A	N/A	Storm Grate/Utility Hazard?	N/A
	Obstruction Type			Storm Grate/Utility Type	
		N/A			N/A
			Yes	Surface Condition? (G/P)	Good

**Remove & Replace Entire Ramp.**

Total Cost: \$ 1850.00
