## **Access Compliance Report Public Rights-of-Way** (Curb Ramps)

Intersection ID: 10822 Main Street: PINCKNEY AV **Cross Street: WOODSIDE AV** Location: **ADA ID: 4EC83C2F767E** Ramp Type: BlendTrans1 Initial Pass/Fail: Fail **Overall Compliance: No** Severity Score: 33.75

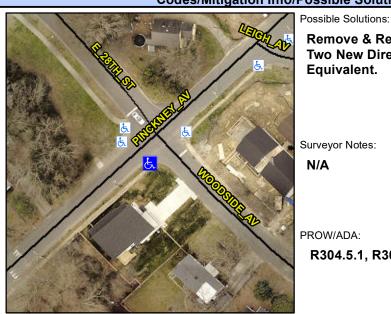
Compliance Description		Data	Comp	liance Description	Data
N/A	Ramp Length (in)	41.5	Yes	BlendTrans Slope (%)	0.8
No	Ramp Width (in)	47.5	No	BlendTrans XSlope (%)	10.0
N/A	Flare Type LT	N/A	N/A	Flare Type RT	N/A
N/A	Flare Slope LT (%)	N/A	N/A	Flare Slope RT (%)	N/A
N/A	Flare Traversable LT?	N/A	N/A	Flare Traversable RT?	N/A
N/A	Landing Length (in)	N/A	N/A	DWS Provided?	N/A
N/A	Landing Width (in)	N/A	N/A	DWS Contrast?	N/A
N/A	Landing Slope (%)	N/A	N/A	DWS Length (in)	N/A
N/A	Landing X Slope (%)	N/A	N/A	DWS Full Width?	N/A
N/A	Landing Curb? (Y/N)	N/A	N/A	DWS Offset (in)	N/A
N/A	Shared Landing?	N/A			
N/A	Gutter Ponding?	N/A	N/A	Gutter Slope (%)	N/A
N/A	Gutter Lip Ht (in)	N/A	N/A	Gutter X Slope (%)	N/A
N/A	Painted X Walk1?	No	N/A	Painted X Walk2?	N/A
	X Walk 1 Direction	To NE		X Walk 2 Direction	N/A
	X Walk 1 Width (in)	N/A		X Walk 2 Width (in)	N/A
	X Walk 1 Slope (%)	5.5		X Walk 2 Slope (%)	N/A
	X Walk 1 X Slope (%)	3.6		X Walk 2 X Slope (%)	N/A

N/A	Ramp inside XWalk1?	N/A	N/A	Ramp inside XWalk2?	N/A
	Road Slope (%)	3.6		Clear Space?	N/A
	Road X Slope (%)	5.5	N/A	Clear Space to XWalk (in)	N/A
N/A	Any Obstructions?	N/A	N/A	Storm Grate/Utility Hazard?	N/A
	Obstruction Type			Storm Grate/Utility Type	
		N/A			N/A
			Yes	Surface Condition? (G/P)	Good

Remove & Replace Curb Ramp With Two New Directional Ramps or Equivalent.

R304.5.1, R304.5.3

Total Cost: 3200.00
