# Access Compliance Report

## Public Rights-of-Way

### (Curb Ramps)

| Intersection ID: 9693 | Main Street: MULBERRY_AV | Cross Street: PATTON_AV | Location: SE |

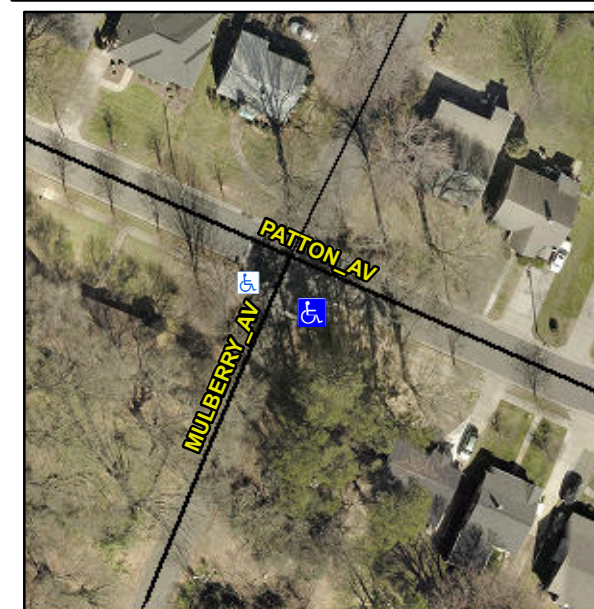
| Severity Score: 7.5 | | | |

**Not Found, R304.2.2-Perp, R304.3.2-  
Para, R304.5.3, R304.5.2, R305.1.4,  
R305.2, R304.5.4**

| Compliance | Description | Data | Compliance | Description | Data |
|---|---|---|---|---|---|
| No | Landing Slope (%) | 2.5 | Yes | DWS Length (in) | 24.0 |
| No | Landing X Slope (%) | 3.6 | No | DWS Full Width? | No |
| N/A | Landing Curb? (Y/N) | N/A | No | DWS Offset LT (in) | 4.5 |
| Yes | Gutter Ponding? | No | No | Gutter Slope (%) | 6.2 |

**Remove & Replace Entire Ramp.  
Remove & Replace Gutter.**

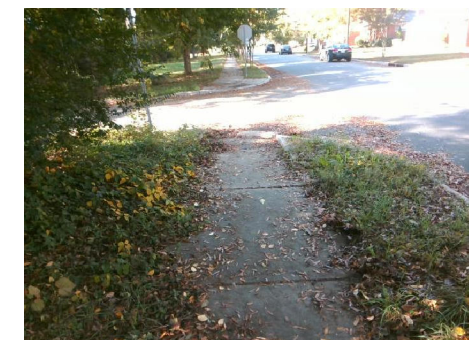
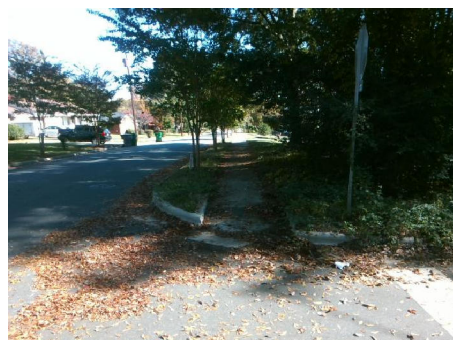
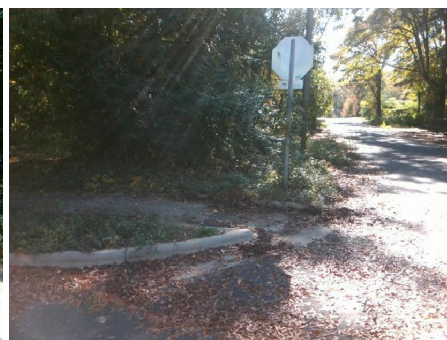
| Compliance | Description | Data | Compliance | Description | Data |
|---|---|---|---|---|---|
| N/A | Ramp Length (in) | 106.5 | No | Grade Break? | No |
