Access Compliance Report

Public Rights-of-Way

(Curb Ramps)

Intersection ID: 15194	Main Street: CENTRAL_DR	Cross Street: OLD_MEADOW_RD	Location: NW
ADA ID: 4ED4FB0EB1E3	Ramp Type: Perp	Initial Pass/Fail: Fail	Overall Compliance: No
		Severity Score: 1.25

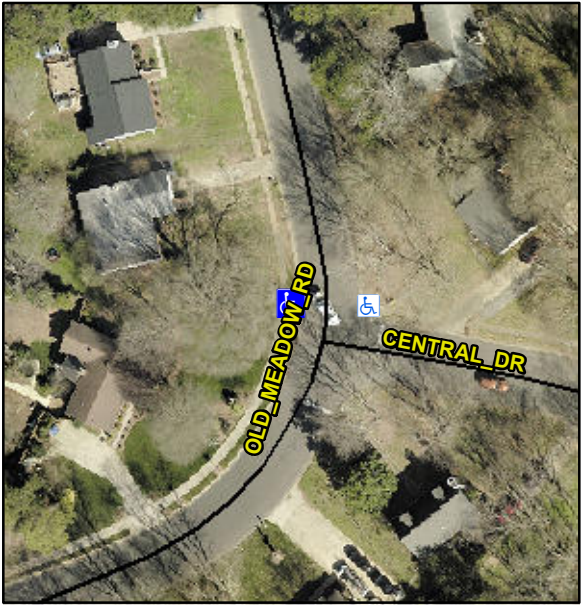
Possible Solutions:		Compliance	Description	Data
	Remove & Replace Entire Ramp.		Yes	Ramp Length (in)	46.5
			No	Ramp Width (in)	48.0
			N/A	Flare Type LT	N/A
			N/A	Flare Slope LT (%)	N/A
			N/A	Flare Traversable LT?	N/A
			N/A	Landing Length (in)	N/A
			N/A	Landing Width (in)	N/A
			N/A	Landing Slope (%)	N/A
			N/A	Landing X Slope (%)	N/A
<p>Surveyor Notes:</p> <p>N/A</p> <p>PROW/ADA:</p> <p>Not Found, R304.5.3</p>			N/A	Flare Type RT	N/A
			N/A	Flare Slope RT (%)	N/A
			N/A	Flare Traversable RT?	N/A
			N/A	DWS Provided?	N/A
			N/A	DWS Contrast?	N/A
			N/A	DWS Length (in)	N/A
			N/A	DWS Full Width?	N/A
			N/A	DWS Offset (in)	N/A
			N/A	Gutter Ponding?	N/A
			N/A	Gutter Lip Ht (in)	N/A
			No	Painted X Walk1?	N/A
			To SE	X Walk 1 Direction	N/A
			N/A	X Walk 1 Width (in)	N/A

5.2	X Walk 1 Slope (%)	N/A
			3.5	X Walk 1 X Slope (%)	N/A
			N/A	Ramp inside XWalk1?	N/A
			N/A	Road Slope (%)	N/A
			N/A	Road X Slope (%)	N/A
			N/A	Any Obstructions?	N/A
				Obstruction Type	N/A
Total Cost:		\$ 1850.00	N/A	Surface Condition? (G/P)	Good
