Access Compliance Report

Public Rights-of-Way

(Curb Ramps)

| Intersection ID: N/A | Main Street: SCOFIELD_RD | Cross Street: WINTERCREST_LN | Location: S |

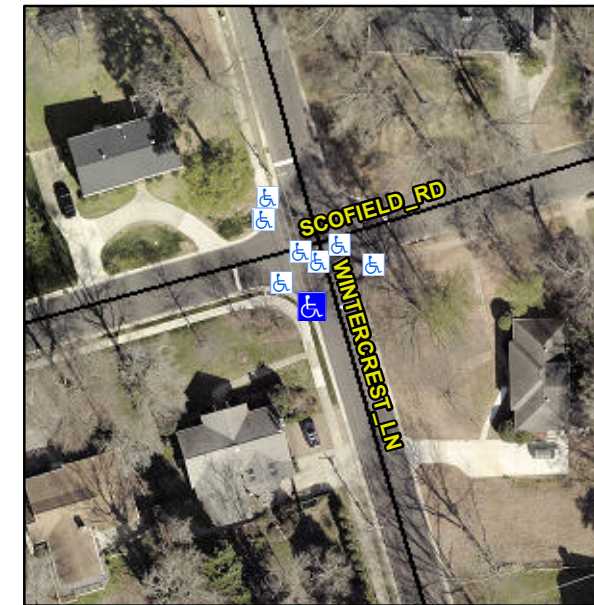
Not Found, R304.5.3, R304.3.2

| Compliance | Description | Data | Compliance | Description | Data |
|---|---|---|---|---|---|
| No | Ramp Slope LT (%) | 9.9 | Yes | Ramp Slope RT (%) | 7.3 |
| Yes | Ramp Width (in) | 74.0 | No | Ramp XSlope (%) | 4.1 |

Remove & Replace Entire Ramp.
