Access Compliance Report

Public Rights-of-Way

(Curb Ramps)

Intersection ID: N/A		Main Street: WOODFOX_DR		Cross Street: STRAWBERRY_LN		Location:		SE	
ADA ID: 4EDD24BFFBE6		Ramp Type: Directional1		Initial Pass/Fail: Fail		Overall Compliance: No		Severity Score: 12.5	
Codes/Mitigation Info/Possible Solution				Field Measurements/Component Compliance					
<div>

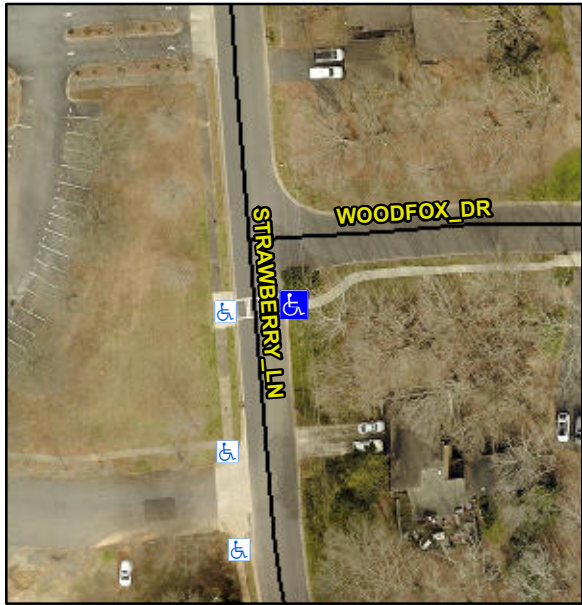
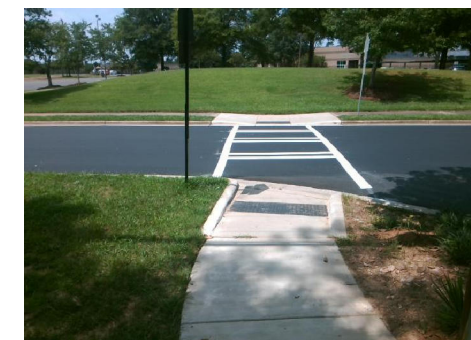
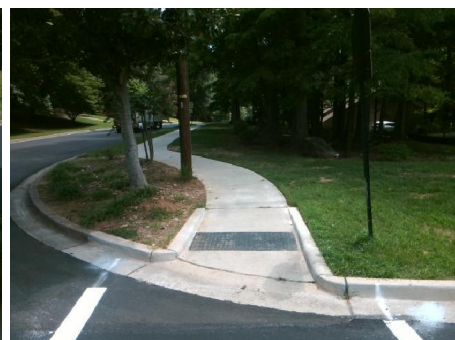
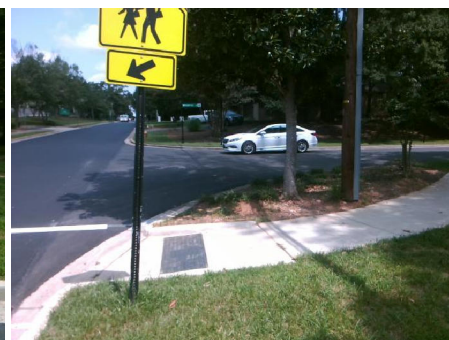
</div> <div>Street 1 NameSTRAWBERRY LN</div> <div>Stop Condition-Street 1None</div> <div>Street 2 NameN/A</div> <div>Stop Condition-Street 2N/A</div>				Possible Solutions:		<div>Remove & Replace Entire Ramp.</div>			
				Surveyor Notes:		N/A			
				PROW/ADA:		R304.2.2			
Total Cost:				\$	1600.00				
				Compliance	Description	Data	Compliance	Description	Data
				N/A	Ramp Length (in)	58.0	N/A	Grade Break?	N/A
				Yes	Ramp Width (in)	60.0	N/A	Grade Break Slope (%)	0.0
				No	Ramp Slope (%)	8.8	N/A	Grade Break XSlope (%)	0.0
				Yes	Ramp XSlope (%)	0.4			
				N/A	Flare Type LT	N/A	N/A	Flare Type RT	N/A

N/A	Flare Slope LT (%)	N/A	N/A	Flare Slope RT (%)	0.0
				N/A	Flare Traversable LT?	N/A	N/A	Flare Traversable RT?	N/A
				N/A	Landing Length (in)	0.0	N/A	DWS Provided?	N/A
				N/A	Landing Width (in)	0.0	N/A	DWS Contrast?	N/A
				N/A	Landing Slope (%)	0.0	N/A	DWS Length (in)	N/A
				N/A	Landing X Slope (%)	0.0	N/A	DWS Full Width?	N/A
				N/A	Landing Curb? (Y/N)	N/A	N/A	DWS Offset LT (in)	N/A
				N/A	Shared Landing?	N/A	N/A	DWS Offset RT (in)	N/A
				N/A	Gutter Ponding?	0.0	N/A	Gutter Slope (%)	N/A
				N/A	Gutter Lip Ht (in)	0.0	N/A	Gutter X Slope (%)	N/A
				N/A	Painted X Walk1?	Yes		Road Slope (%)	5.0
					X Walk 1 Direction	To W		Road X Slope (%)	4.0
					X Walk 1 Width (in)	108.0		Clear Space?	N/A
					X Walk 1 Slope (%)	5.0	N/A	Clear Space to XWalk (in)	N/A
					X Walk 1 X Slope (%)	4.0	N/A	Storm Grate/Utility Hazard?	N/A
				N/A	Ramp inside XWalk1?	Yes		Storm Grate/Utility Type	
				N/A	Any Obstructions?	N/A			N/A

Obstruction Type		Yes	Surface Condition? (G/P)	Good
						N/A	N/A	Curb Slope (%)	7.0
