# Access Compliance Report

## Public Rights-of-Way (Curb Ramps)

| Intersection ID: 10034966 | Main Street: PROVIDENCE_RD_WEST | Cross Street: N/A | Location: NE |
| ADA ID: 4EE74B42EEC9 | Ramp Type: Directional1 | Initial Pass/Fail: Pass | Overall Compliance: No |

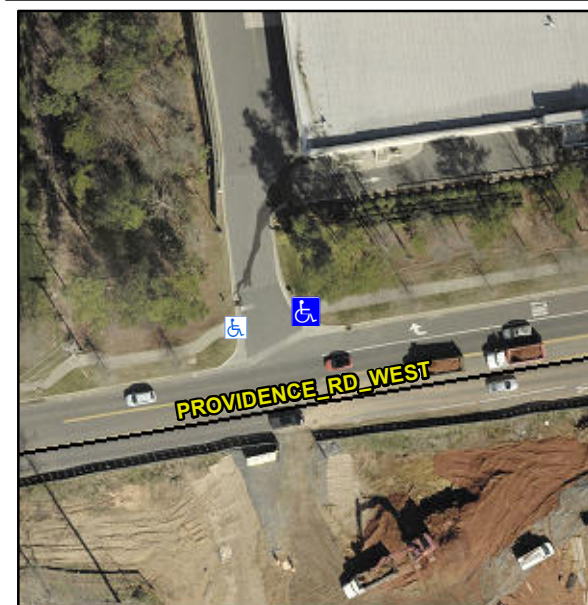
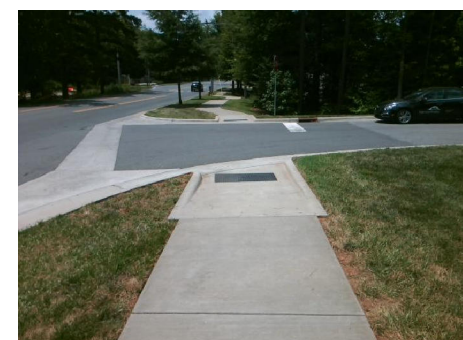
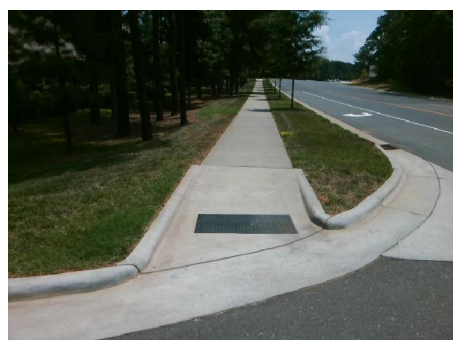
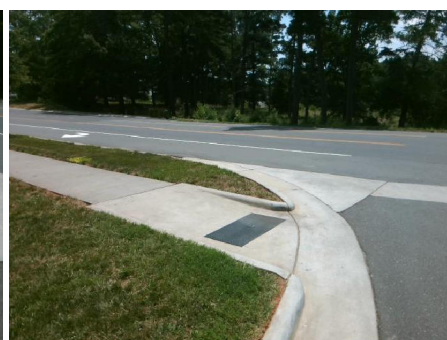
**R305.2**

| Compliance | Description | Data | Compliance | Description | Data |
|---|---|---|---|---|---|
| N/A | Shared Landing? | No | No | DWS Offset RT (in) | 6.0 |

**Remove & Replace Detectable Warning System.**
