# Access Compliance Report

## Public Rights-of-Way

### (Curb Ramps)

Intersection ID: 51181	Main Street: FIRCREST_DR	Cross Street: WHIPPET_RIDGE_CT	Location: NE
ADA ID: 4EED3DE4135F	Ramp Type: PerpDiag	Initial Pass/Fail: Fail	Overall Compliance: No
Severity Score: 12.5			
Codes/Mitigation Info/Possible Solution		Field Measurements/Component Compliance

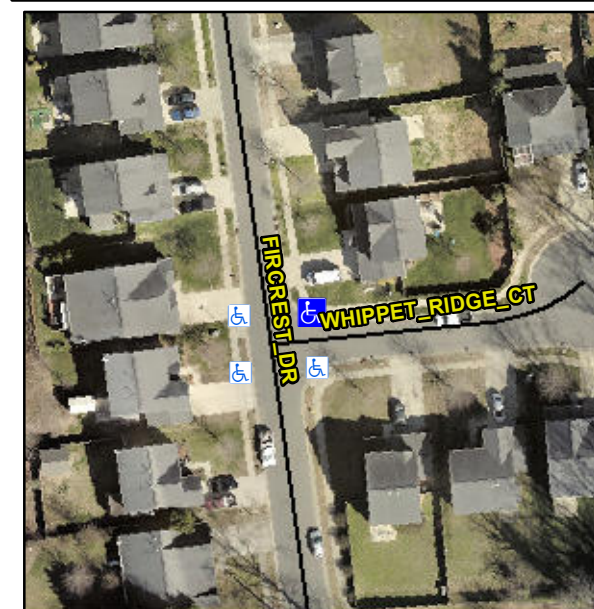
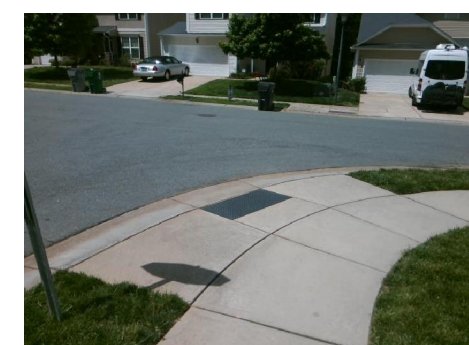
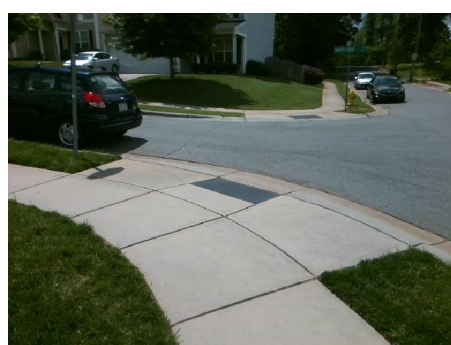
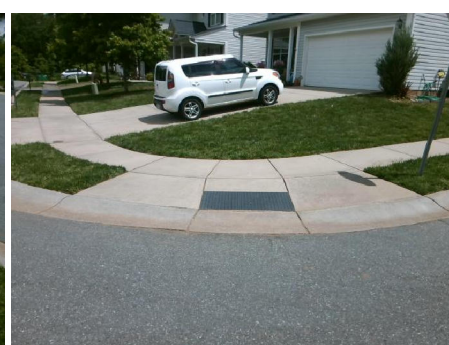
Compliance	Description	Data	Compliance	Description	Data
N/A	Ramp Length (in)	48.0	Yes	Ramp Slope (%)	6.8
Yes	Ramp Width (in)	48.0	No	Ramp XSlope (%)	6.4
N/A	Flare Type LT	N/A	N/A	Flare Type RT	N/A
N/A	Flare Slope LT (%)	N/A	N/A	Flare Slope RT (%)	N/A
N/A	Flare Traversable LT?	N/A	N/A	Flare Traversable RT?	N/A
N/A	Landing Length (in)	N/A	N/A	DWS Provided?	N/A
N/A	Landing Width (in)	N/A	N/A	DWS Contrast?	N/A
N/A	Landing Slope (%)	N/A	N/A	DWS Length (in)	N/A
N/A	Landing X Slope (%)	N/A	N/A	DWS Full Width?	N/A
N/A	Landing Curb? (Y/N)	N/A	N/A	DWS Offset (in)	N/A
N/A	Shared Landing?	N/A			
N/A	Gutter Ponding?	N/A	N/A	Gutter Slope (%)	N/A
N/A	Gutter Lip Ht (in)	N/A	N/A	Gutter X Slope (%)	N/A
N/A	Painted X Walk1?	No	N/A	Painted X Walk2?	No
	X Walk 1 Direction	To W		X Walk 2 Direction	To S
N/A	X Walk 1 Width (in)	N/A	N/A	X Walk 2 Width (in)	N/A
	X Walk 1 Slope (%)	0.3		X Walk 2 Slope (%)	5.0
	X Walk 1 X Slope (%)	5.0		X Walk 2 X Slope (%)	2.2

N/A	Ramp inside XWalk1?	N/A	N/A	Ramp inside XWalk2?	N/A
	Road Slope (%)	3.4	N/A	Clear Space?	N/A
	Road X Slope (%)	3.6	N/A	Clear Space to XWalk (in)	N/A
N/A	Any Obstructions?	N/A	N/A	Storm Grate/Utility Hazard?	N/A
	Obstruction Type			Storm Grate/Utility Type	
		N/A			N/A
		Yes		Surface Condition? (G/P)	Good

**Remove & Replace Curb Ramp With Two New Directional Ramps or Equivalent.**

**R304.5.3**
