# Access Compliance Report

## Public Rights-of-Way

### (Curb Ramps)

| Intersection ID: 3051 | Main Street: WHITE_STAG_DR | Cross Street: WHITE_STAG_DR | Location: NW |

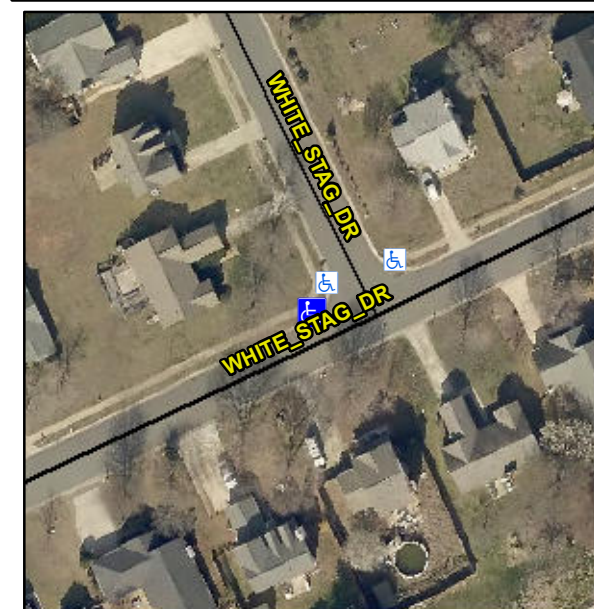
| ADA ID: 4EF7B76F33D2 | Ramp Type: Perp | Initial Pass/Fail: Fail | Overall Compliance: No |
| Severity Score: 60 | | | |

**Not Found, R304.5.1, R304.2.2**

| Compliance | Description | Data | Compliance | Description | Data |
|---|---|---|---|---|---|
| N/A | Ramp Length (in) | 46.0 | No | Ramp Slope (%) | 13.6 |
| No | Ramp Width (in) | 31.0 | Yes | Ramp XSlope (%) | 1.4 |

**Remove & Replace Entire Ramp.**

Total Cost: \$ 1850.00
