Access Compliance Report

Public Rights-of-Way

(Curb Ramps)

Intersection ID: 24825	Main Street: CHOATE_CR	Cross Street: MOSS_RD	Location: NW
ADA ID: 4EF89C8C1B84	Ramp Type: PerpDiag	Initial Pass/Fail: Fail	Overall Compliance: No
Severity Score: 12.5			
Codes/Mitigation Info/Possible Solution		Field Measurements/Component Compliance

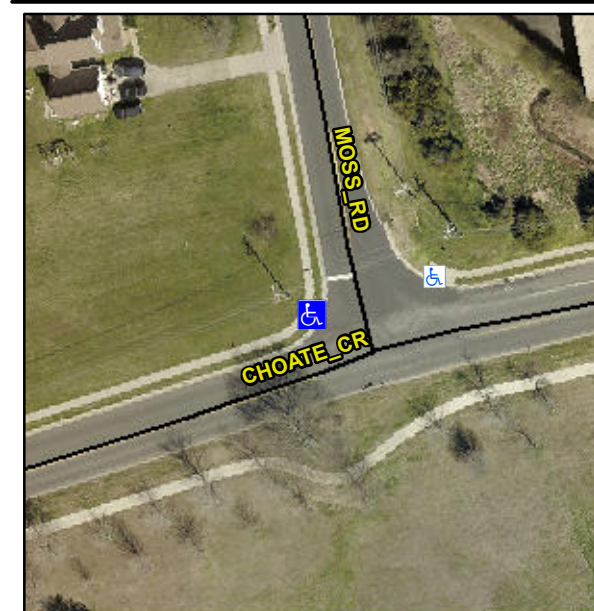
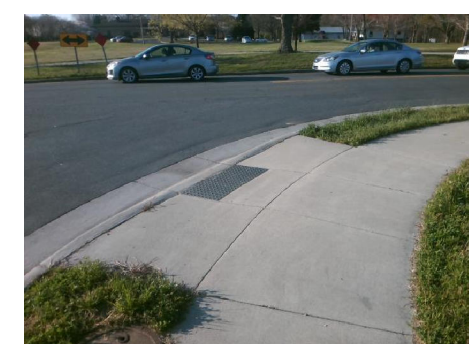
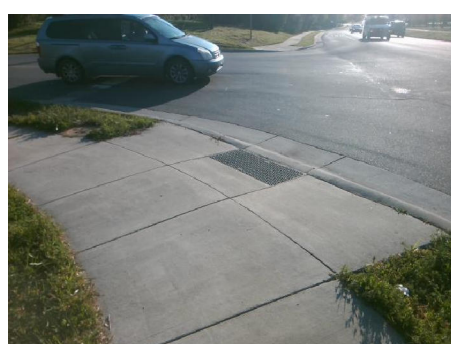
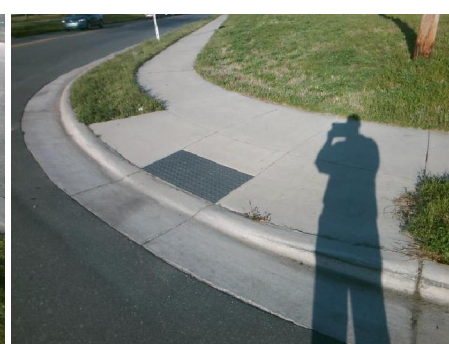
Compliance	Description	Data	Compliance	Description	Data
N/A	Ramp Length (in)	47.0	No	Ramp Slope (%)	10.7
Yes	Ramp Width (in)	48.0	Yes	Ramp XSlope (%)	0.5
N/A	Flare Type LT	N/A	N/A	Flare Type RT	N/A
N/A	Flare Slope LT (%)	N/A	N/A	Flare Slope RT (%)	N/A
N/A	Flare Traversable LT?	N/A	N/A	Flare Traversable RT?	N/A
N/A	Landing Length (in)	N/A	N/A	DWS Provided?	N/A
N/A	Landing Width (in)	N/A	N/A	DWS Contrast?	N/A
N/A	Landing Slope (%)	N/A	N/A	DWS Length (in)	N/A
N/A	Landing X Slope (%)	N/A	N/A	DWS Full Width?	N/A
N/A	Landing Curb? (Y/N)	N/A	N/A	DWS Offset (in)	N/A
N/A	Shared Landing?	N/A			
N/A	Gutter Ponding?	N/A	N/A	Gutter Slope (%)	N/A
N/A	Gutter Lip Ht (in)	N/A	N/A	Gutter X Slope (%)	N/A
N/A	Painted X Walk1?	No	N/A	Painted X Walk2?	No
	X Walk 1 Direction	To S		X Walk 2 Direction	To E
N/A	X Walk 1 Width (in)	N/A	N/A	X Walk 2 Width (in)	N/A
	X Walk 1 Slope (%)	1.1		X Walk 2 Slope (%)	1.1
	X Walk 1 X Slope (%)	0.3		X Walk 2 X Slope (%)	3.5

N/A	Ramp inside XWalk1?	N/A	N/A	Ramp inside XWalk2?	N/A
	Road Slope (%)	0.3	N/A	Clear Space?	N/A
	Road X Slope (%)	0.5	N/A	Clear Space to XWalk (in)	N/A
N/A	Any Obstructions?	N/A	N/A	Storm Grate/Utility Hazard?	N/A
	Obstruction Type			Storm Grate/Utility Type	
		N/A			N/A
		Yes		Surface Condition? (G/P)	Good

Remove & Replace Curb Ramp With Two New Directional Ramps or Equivalent.

R304.2.2
