Access Compliance Report

Public Rights-of-Way

(Curb Ramps)

Intersection ID: 8445	Main Street: IRMA_ST	Cross Street: LASALLE_ST	Location: SE
ADA ID: 4EFA28A10DAD	Ramp Type: PerpDiag	Initial Pass/Fail: Fail	Overall Compliance: No
		Severity Score: 35

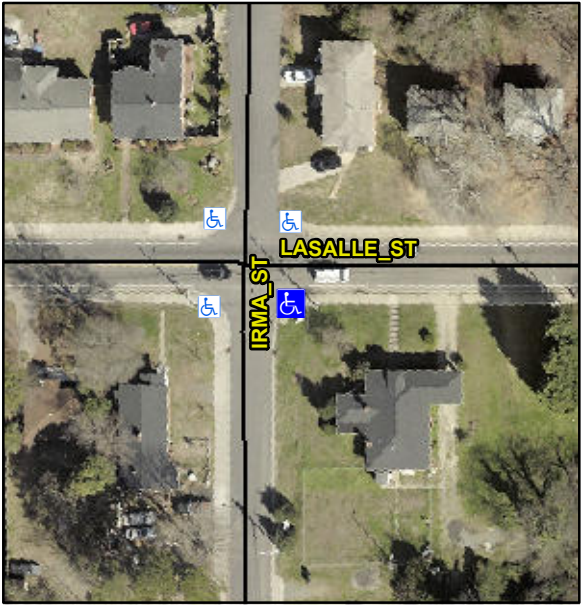
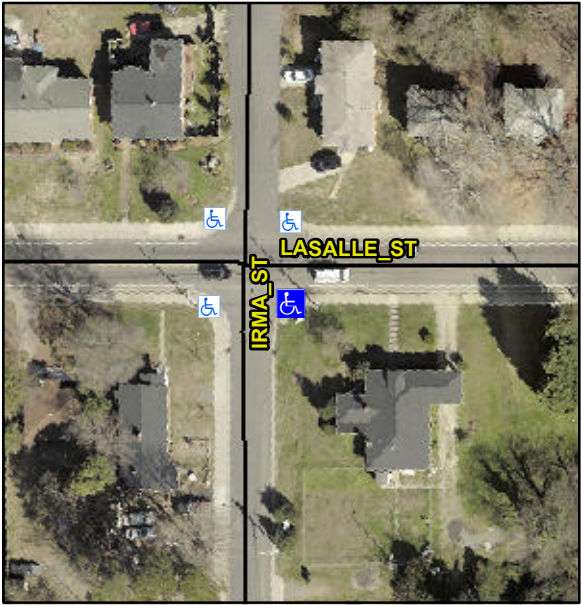
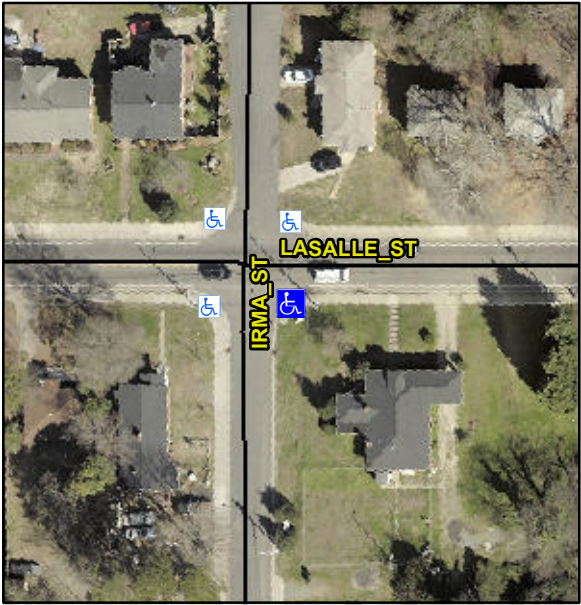
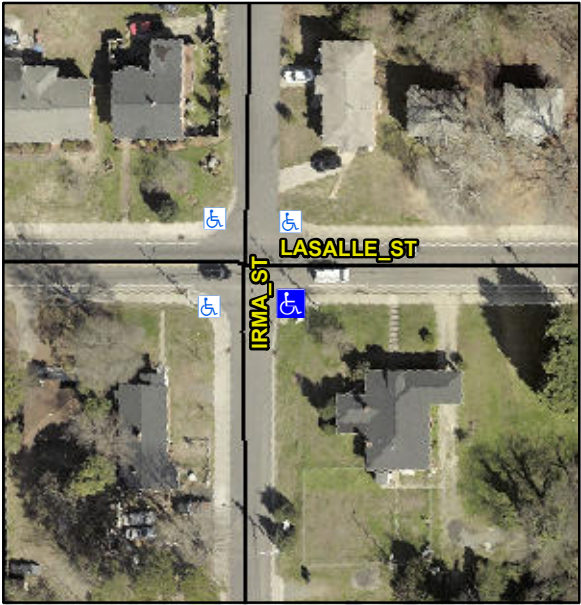
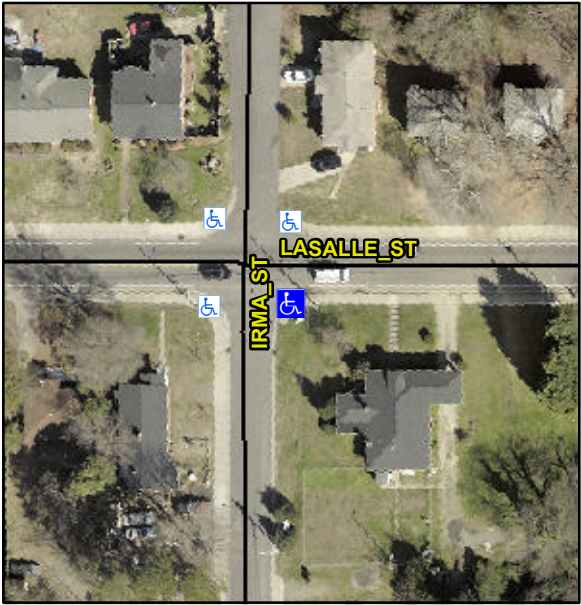
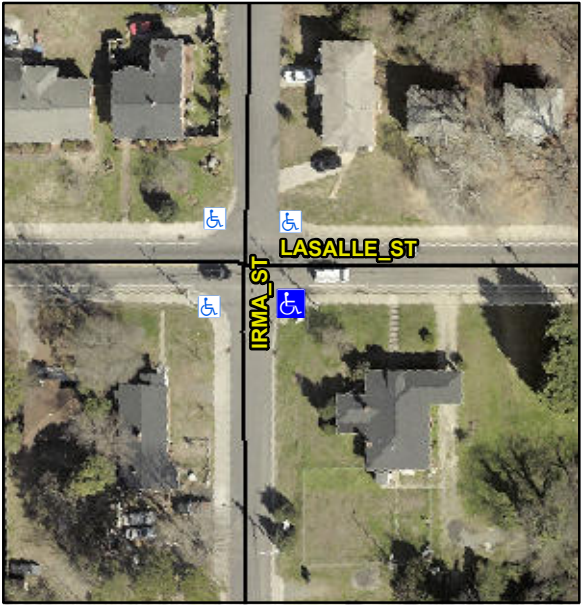
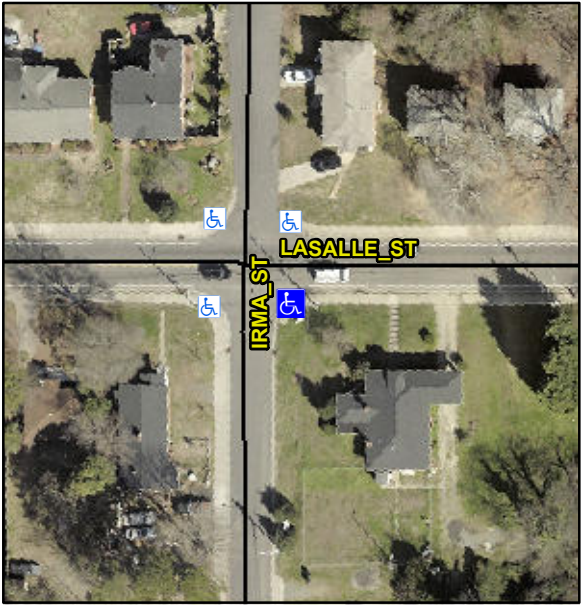
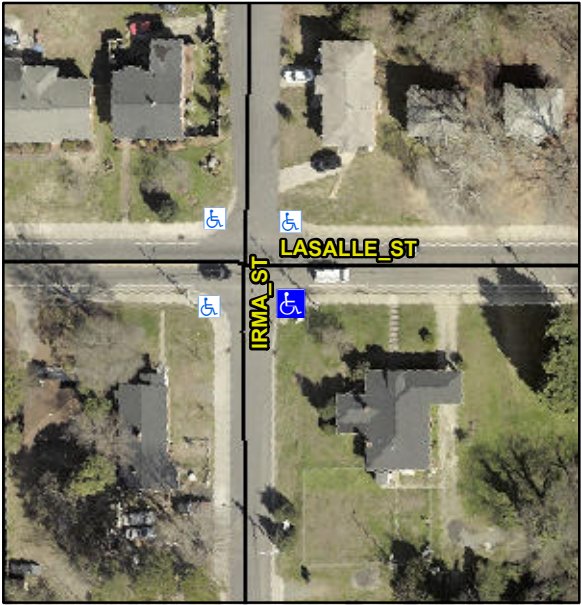
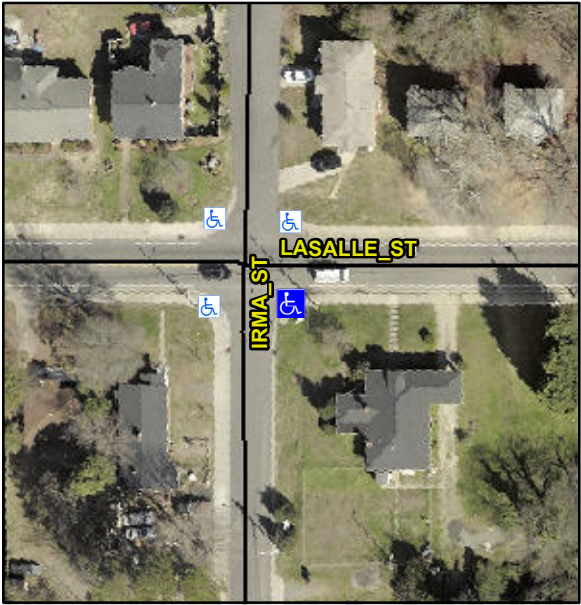
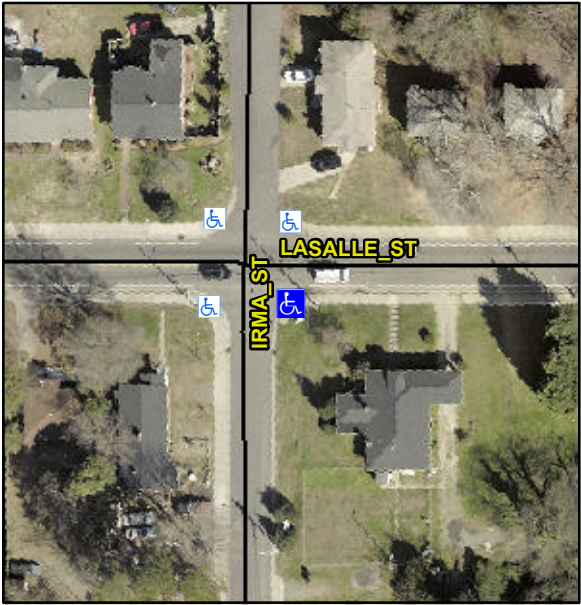
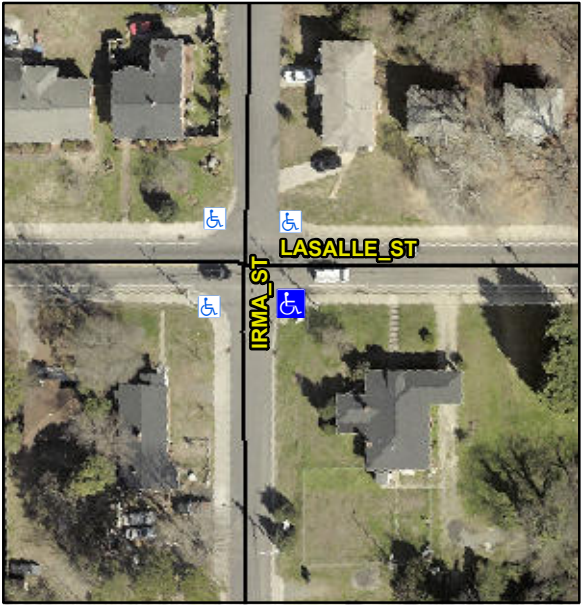
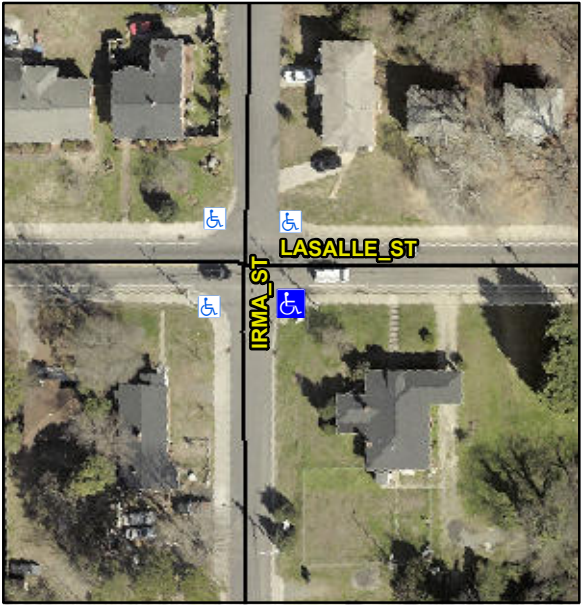
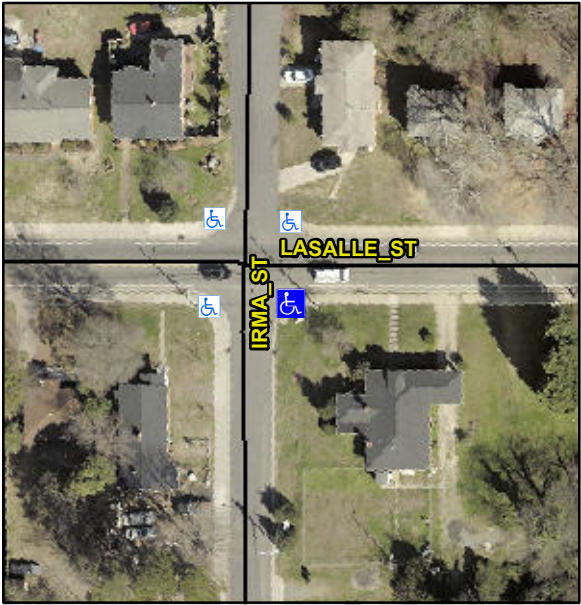
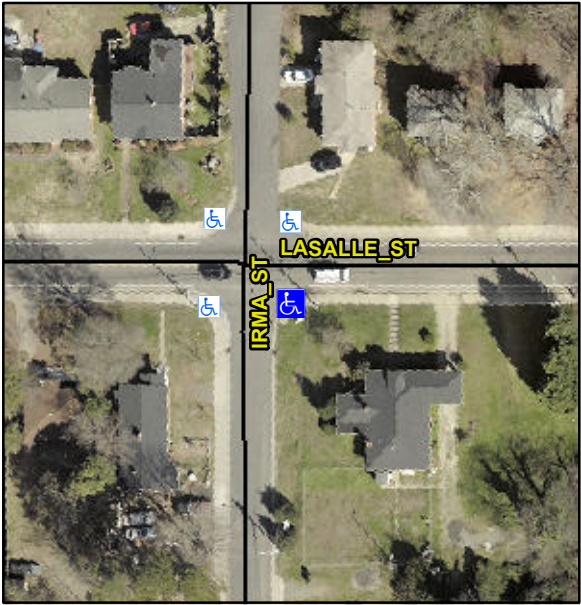
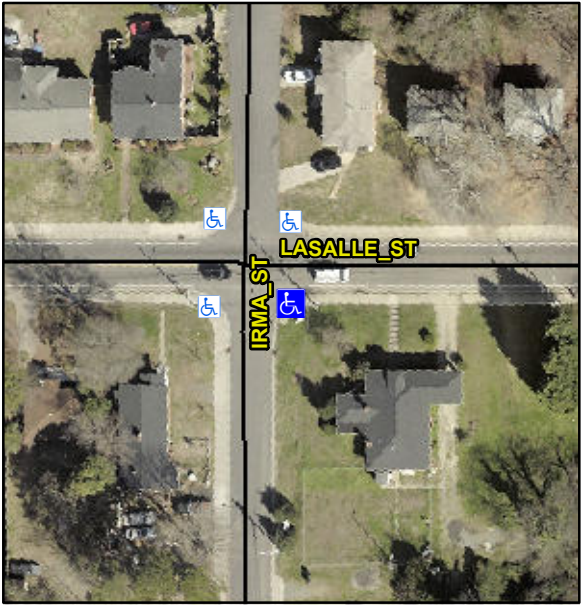
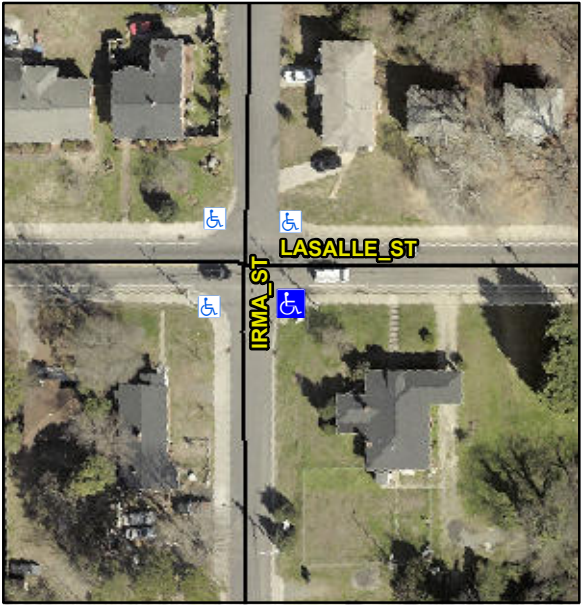
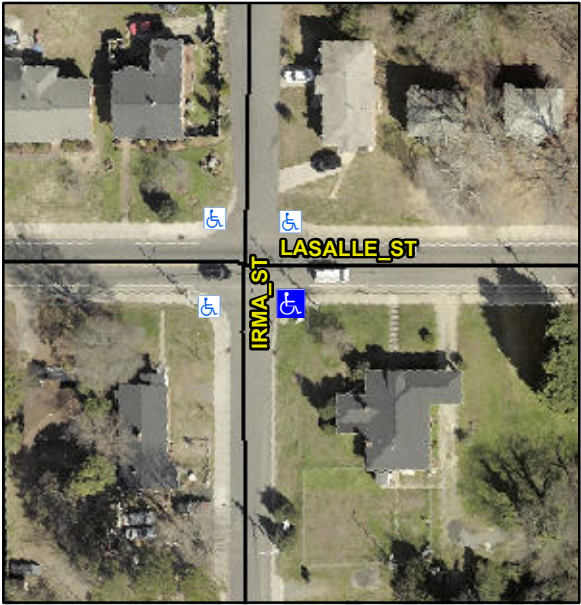
Surveyor Notes:		N/A	Ramp Length (in)	61.0
	N/A		No	Ramp Width (in)	36.5

PROW/ADA:		N/A	Flare Type LT	N/A
	Not Found, R304.5.1, R304.2.2, R304.5.3		N/A	Flare Slope LT (%)	N/A

Possible Solutions:		Compliance	Description	Data
	Remove & Replace Curb Ramp With Two New Directional Ramps or Equivalent.		Compliance	Description	Data
