Intersection ID: 12646 Main Street: LEVINE_AVENUE_OF_THE_ART3oss Street: S_TRYON_ST Location: N

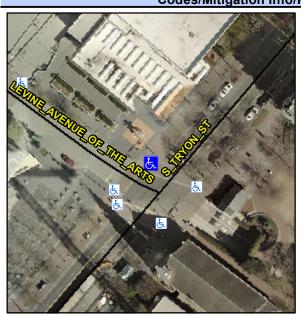
3200.00

Field Measurements/Component Compliance						
Compliance Description		Data	Comp	liance Description	Data	
N/A	Ramp Length (in)	74.0	No	Ramp Slope (%)	11.1	
Yes	Ramp Width (in)	166.0	Yes	Ramp XSlope (%)	0.7	
N/A	Flare Type LT	N/A	N/A	Flare Type RT	N/A	
N/A	Flare Slope LT (%)	N/A	N/A	Flare Slope RT (%)	N/A	
N/A	Flare Traversable LT?	N/A	N/A	Flare Traversable RT?	N/A	
N/A	Landing Length (in)	N/A	N/A	DWS Provided?	N/A	
N/A	Landing Width (in)	N/A	N/A	DWS Contrast?	N/A	
N/A	Landing Slope (%)	N/A	N/A	DWS Length (in)	N/A	
N/A	Landing X Slope (%)	N/A	N/A	DWS Full Width?	N/A	
N/A	Landing Curb? (Y/N)	N/A	N/A	DWS Offset (in)	N/A	
N/A	Shared Landing?	N/A				
N/A	Gutter Ponding?	N/A	N/A	Gutter Slope (%)	N/A	
N/A	Gutter Lip Ht (in)	N/A	N/A	Gutter X Slope (%)	N/A	
N/A	Painted X Walk1?	Yes	N/A	Painted X Walk2?	Yes	
	X Walk 1 Direction	To SW		X Walk 2 Direction	To SE	
N/A	X Walk 1 Width (in)	140.0	N/A	X Walk 2 Width (in)	145.0
