Intersection ID: 9808	Main Street: N_TURNER_AV	Cross Street: SELDON_DR	Location:	S
ADA ID: 4F0351BB805A	Ramp Type: BlendTrans1	Initial Pass/Fail: Fail	Overall Compliance: No	Severity Score: 10

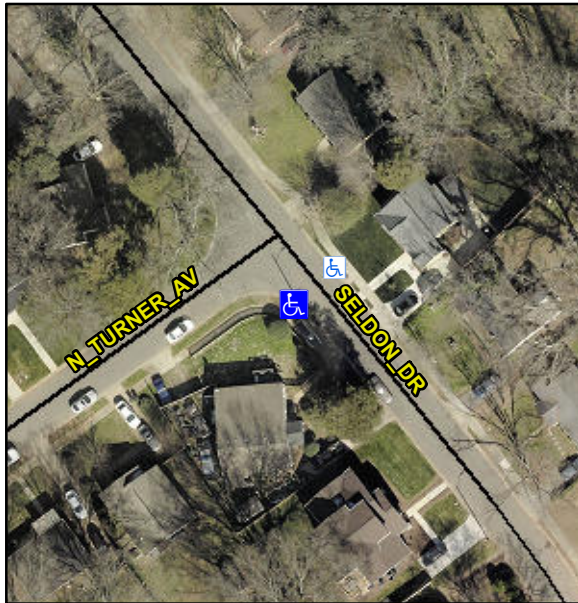
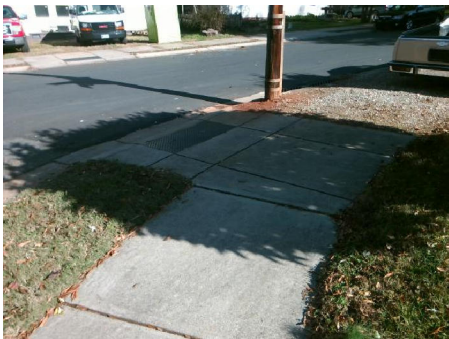
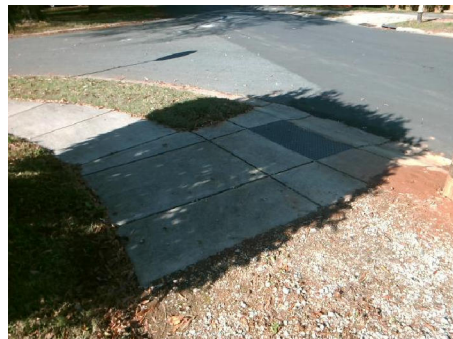
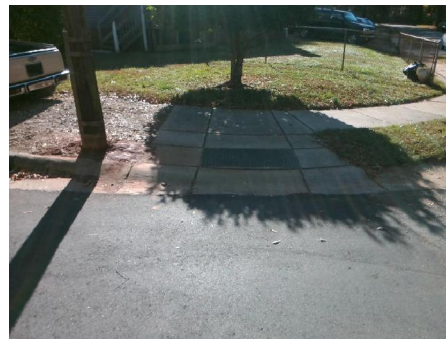
**NO LT SW**

**Not Found, R304.5.1, R304.5.3**

Compliance	Description	Data	Compliance	Description	Data
N/A	Ramp Length (in)	49.0	Yes	BlendTrans Slope (%)	4.5
No	Ramp Width (in)	46.0	No	BlendTrans XSlope (%)	3.4
N/A	Flare Type LT	N/A	N/A	Flare Type RT	N/A
N/A	Flare Slope LT (%)	N/A	N/A	Flare Slope RT (%)	N/A
N/A	Flare Traversable LT?	N/A	N/A	Flare Traversable RT?	N/A
N/A	Landing Length (in)	N/A	N/A	DWS Provided?	N/A
N/A	Landing Width (in)	N/A	N/A	DWS Contrast?	N/A
N/A	Landing Slope (%)	N/A	N/A	DWS Length (in)	N/A
N/A	Landing X Slope (%)	N/A	N/A	DWS Full Width?	N/A
N/A	Landing Curb? (Y/N)	N/A	N/A	DWS Offset (in)	N/A
N/A	Shared Landing?	N/A			
N/A	Gutter Ponding?	N/A	N/A	Gutter Slope (%)	N/A
N/A	Gutter Lip Ht (in)	0.5	N/A	Gutter X Slope (%)	N/A
N/A	Painted X Walk1?	No	N/A	Painted X Walk2?	N/A
	X Walk 1 Direction	To NE		X Walk 2 Direction	N/A
	X Walk 1 Width (in)	N/A		X Walk 2 Width (in)	N/A
	X Walk 1 Slope (%)	3.5		X Walk 2 Slope (%)	N/A
	X Walk 1 X Slope (%)	2.1		X Walk 2 X Slope (%)	N/A

N/A	Ramp inside XWalk1?	N/A	N/A	Ramp inside XWalk2?	N/A
	Road Slope (%)	2.1		Clear Space?	N/A
	Road X Slope (%)	3.5	N/A	Clear Space to XWalk (in)	N/A
N/A	Any Obstructions?	N/A	N/A	Storm Grate/Utility Hazard?	N/A
	Obstruction Type			Storm Grate/Utility Type	
		N/A			N/A
			Yes	Surface Condition? (G/P)	Good
			No	Curb Slope (%)	15.0

**Remove & Replace Curb Ramp With Two New Directional Ramps or Equivalent.**
