Access Compliance Report

Public Rights-of-Way

| Intersection ID: 23733 | Main Street: ALLEGRO_CT | Cross Street: CEDAR_CROFT_DR | Location: | N |
| ADA ID: 4F03770BB170 | Ramp Type: PerpDiag | Initial Pass/Fail: Fail | Overall Compliance: No | Severity Score: 13.75 |

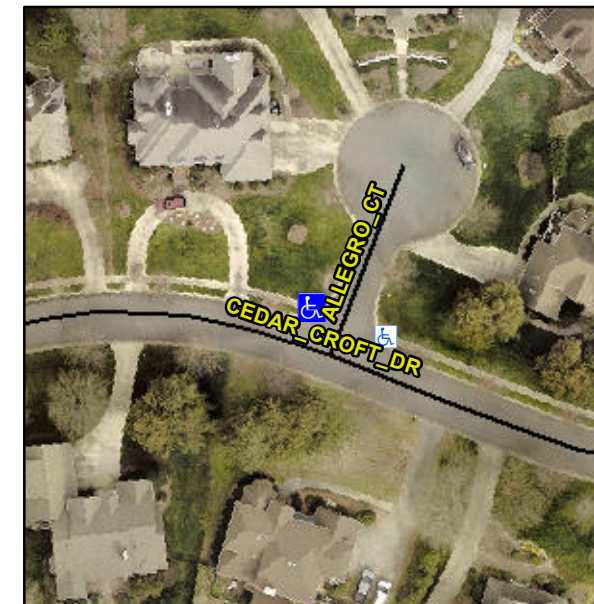
Not Found, R304.2.2, R304.5.3

| Compliance | Description | Data | Compliance | Description | Data |
|---|---|---|---|---|---|
| N/A | Ramp Length (in) | 30.0 | No | Ramp Slope (%) | 9.3 |
| Yes | Ramp Width (in) | 48.0 | No | Ramp XSlope (%) | 2.8 |

Remove & Replace Curb Ramp With Two New Directional Ramps or Equivalent.

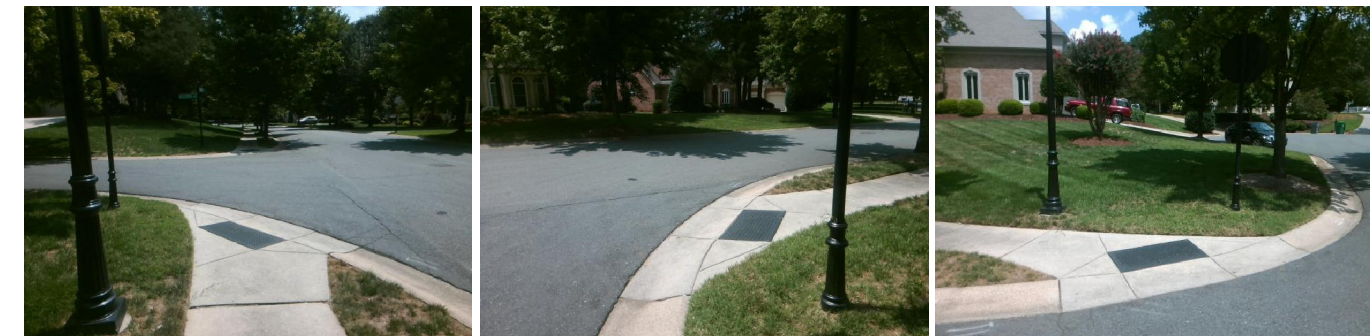
Street 1 Name **CEDAR CROFT DR**
 Stop Condition-Street 2 **None**
 Street 2 Name **ALLEGRO CT**
 Stop Condition-Street 1 **StopSign**
