Access Compliance Report

Public Rights-of-Way

(Curb Ramps)

Intersection ID: 47628	Main Street: EASTFIELD_RD	Cross Street: WALLACE_POND_DR	Location: NW
ADA ID: 4F0575758C50	Ramp Type: BlendTrans1	Initial Pass/Fail: Fail	Overall Compliance: No
		Severity Score: 21.25

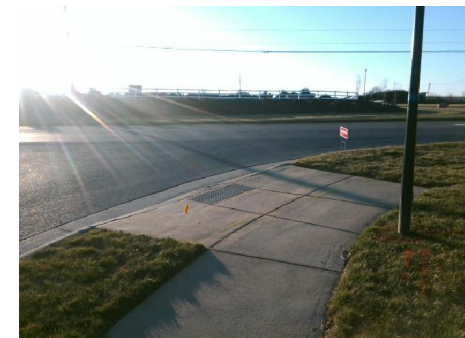
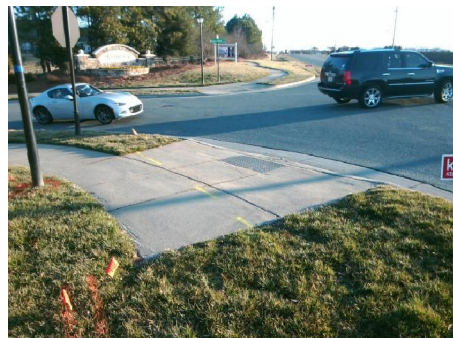
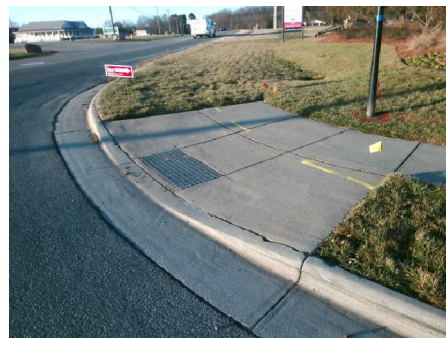
Compliance	Description	Data	Compliance	Description	Data
N/A	Ramp Length (in)	71.0	Yes	BlendTrans Slope (%)	1.4
No	Ramp Width (in)	47.0	No	BlendTrans XSlope (%)	5.1
N/A	Flare Type LT	N/A	N/A	Flare Type RT	N/A
N/A	Flare Slope LT (%)	N/A	N/A	Flare Slope RT (%)	N/A
N/A	Flare Traversable LT?	N/A	N/A	Flare Traversable RT?	N/A
N/A	Landing Length (in)	N/A	N/A	DWS Provided?	N/A
N/A	Landing Width (in)	N/A	N/A	DWS Contrast?	N/A
N/A	Landing Slope (%)	N/A	N/A	DWS Length (in)	N/A
N/A	Landing X Slope (%)	N/A	N/A	DWS Full Width?	N/A
N/A	Landing Curb? (Y/N)	N/A	N/A	DWS Offset (in)	N/A
N/A	Shared Landing?	N/A			
N/A	Gutter Ponding?	N/A	N/A	Gutter Slope (%)	N/A
N/A	Gutter Lip Ht (in)	N/A	N/A	Gutter X Slope (%)	N/A
N/A	Painted X Walk1?	No	N/A	Painted X Walk2?	N/A
	X Walk 1 Direction	To NE		X Walk 2 Direction	N/A
	X Walk 1 Width (in)	N/A		X Walk 2 Width (in)	N/A
	X Walk 1 Slope (%)	2.4		X Walk 2 Slope (%)	N/A
	X Walk 1 X Slope (%)	5.0		X Walk 2 X Slope (%)	N/A

N/A	Ramp inside XWalk1?	N/A	N/A	Ramp inside XWalk2?	N/A
	Road Slope (%)	5.0		Clear Space?	N/A
	Road X Slope (%)	2.4	N/A	Clear Space to XWalk (in)	N/A
N/A	Any Obstructions?	N/A	N/A	Storm Grate/Utility Hazard?	N/A
	Obstruction Type			Storm Grate/Utility Type	
		N/A			N/A
			Yes	Surface Condition? (G/P)	Good
			N/A	Curb Slope (%)	4.1

Remove & Replace Curb Ramp With Two New Directional Ramps or Equivalent.
