# Access Compliance Report

## Public Rights-of-Way

### (Curb Ramps)

| Intersection ID: 7329 | Main Street: DAWNSHIRE_AV | Cross Street: NORTHCLIFF_DR | Location: SW |

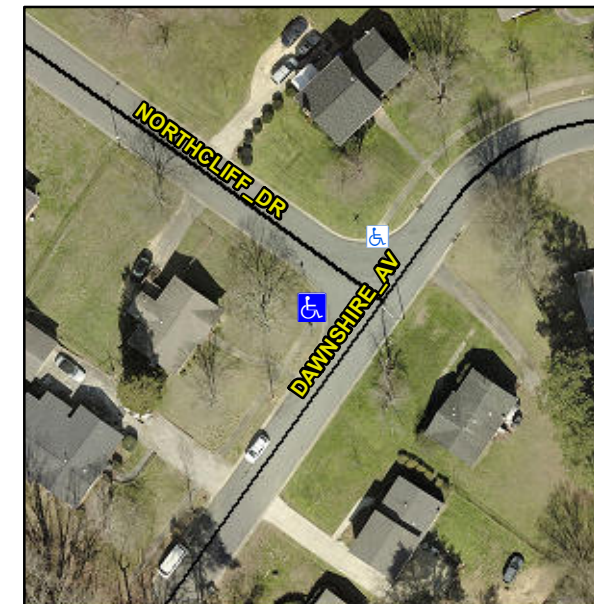
**Not Found, R304.5.3, R304.2.1, R302.7.2, R304.5.4**

| Compliance | Description | Data | Compliance | Description | Data |
|---|---|---|---|---|---|
| Yes | Ramp Width (in) | 48.0 | No | BlendTrans XSlope (%) | 2.6 |
| No | Landing Width (in) | 47.0 | Yes | DWS Contrast? | Yes |
| Yes | Gutter Ponding? | No | No | Gutter Slope (%) | 5.4 |
| No | Gutter Lip Ht (in) | 2.0 | Yes | Gutter X Slope (%) | 0.2 |
| | | | No | Curb Slope (%) | 13.3 |

**Remove & Replace Curb Ramp With Two New Directional Ramps or Equivalent. Remove & Replace Gutter.**
