Access Compliance Report

Public Rights-of-Way

(Curb Ramps)

Intersection ID: 7087	Main Street: COTTAGEVILLE_LN	Cross Street: MELYNDA_RD	Location:	N
ADA ID: 4F0A412E63FF	Ramp Type: Perp	Initial Pass/Fail: Fail	Overall Compliance: No	Severity Score: 21.25

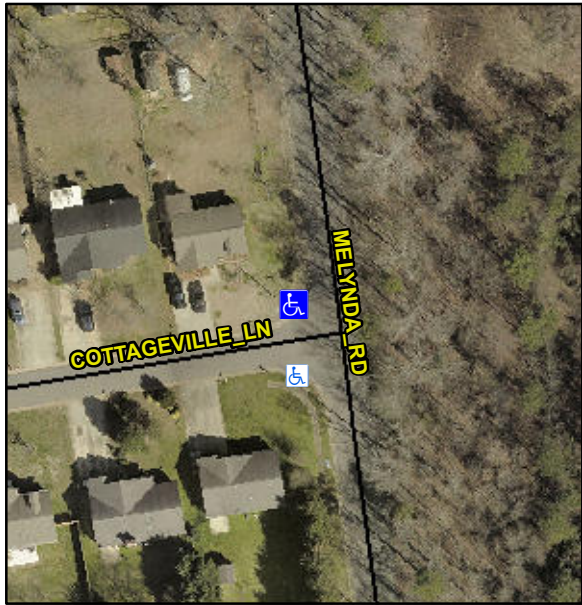
Possible Solutions:		Compliance	Description	Data	Compliance	Description	Data
	Remove & Replace Entire Ramp.		N/A	Ramp Length (in)	48.0	No	Ramp Slope (%)	10.7
			No	Ramp Width (in)	45.0	Yes	Ramp XSlope (%)	0.1
			N/A	Flare Type LT	N/A	N/A	Flare Type RT	N/A
			N/A	Flare Slope LT (%)	N/A	N/A	Flare Slope RT (%)	N/A
			N/A	Flare Traversable LT?	N/A	N/A	Flare Traversable RT?	N/A
			N/A	Landing Length (in)	N/A	N/A	DWS Provided?	N/A
			N/A	Landing Width (in)	N/A	N/A	DWS Contrast?	N/A
			N/A	Landing Slope (%)	N/A	N/A	DWS Length (in)	N/A
			N/A	Landing X Slope (%)	N/A	N/A	DWS Full Width?	N/A
Surveyor Notes:			N/A	Landing Curb? (Y/N)	N/A	N/A	DWS Offset (in)	N/A
N/A			N/A	Shared Landing?	N/A			
PROW/ADA:			N/A	Gutter Ponding?	N/A	N/A	Gutter Slope (%)	N/A
Not Found, R304.5.1, R304.2.2			N/A	Gutter Lip Ht (in)	N/A	N/A	Gutter X Slope (%)	N/A

N/A	Painted X Walk1?	No	N/A	Painted X Walk2?	N/A
				X Walk 1 Direction	To S		X Walk 2 Direction	N/A
			N/A	X Walk 1 Width (in)	N/A	N/A	X Walk 2 Width (in)	N/A
				X Walk 1 Slope (%)	0.9		X Walk 2 Slope (%)	N/A
				X Walk 1 X Slope (%)	1.5		X Walk 2 X Slope (%)	N/A
			N/A	Ramp inside XWalk1?	N/A	N/A	Ramp inside XWalk2?	N/A
				Road Slope (%)	N/A	N/A	Clear Space?	N/A
				Road X Slope (%)	N/A	N/A	Clear Space to XWalk (in)	N/A
			N/A	Any Obstructions?	N/A	N/A	Storm Grate/Utility Hazard?	N/A
				Obstruction Type			Storm Grate/Utility Type	
					N/A			N/A
						Yes	Surface Condition? (G/P)	Good
Total Cost:		\$ 1850.00						
Street 1 Name		COTTAGEVILLE LN						
Stop Condition-Street 2		StopSign						
Street 2 Name		N/A						
Stop Condition-Street 1		N/A
