Access Compliance Report

Public Rights-of-Way

(Curb Ramps)

Intersection ID: 48302	Main Street: CAPRA_CT	Cross Street: FAZENDA_DR	Location:	E
ADA ID: 4F0C8FC4C7CC	Ramp Type: PerpDiag	Initial Pass/Fail: Fail	Overall Compliance: No	Severity Score: 10

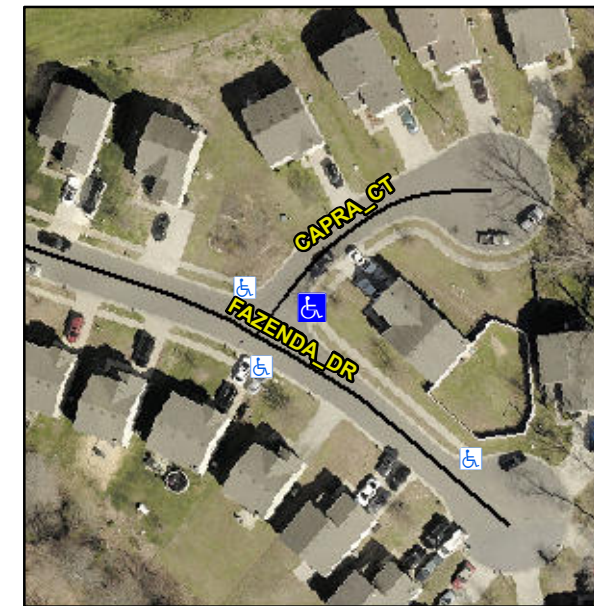
Not Found, R304.5.1, R304.5.3

Compliance	Description	Data	Compliance	Description	Data
N/A	Ramp Length (in)	49.0	Yes	Ramp Slope (%)	5.4
No	Ramp Width (in)	47.5	No	Ramp XSlope (%)	3.1
N/A	Flare Type LT	N/A	N/A	Flare Type RT	N/A
N/A	Flare Slope LT (%)	N/A	N/A	Flare Slope RT (%)	N/A
N/A	Flare Traversable LT?	N/A	N/A	Flare Traversable RT?	N/A
N/A	Landing Length (in)	N/A	N/A	DWS Provided?	N/A
N/A	Landing Width (in)	N/A	N/A	DWS Contrast?	N/A
N/A	Landing Slope (%)	N/A	N/A	DWS Length (in)	N/A
N/A	Landing X Slope (%)	N/A	N/A	DWS Full Width?	N/A
N/A	Landing Curb? (Y/N)	N/A	N/A	DWS Offset (in)	N/A
N/A	Shared Landing?	N/A			
N/A	Gutter Ponding?	N/A	N/A	Gutter Slope (%)	N/A
N/A	Gutter Lip Ht (in)	N/A	N/A	Gutter X Slope (%)	N/A
N/A	Painted X Walk1?	No	N/A	Painted X Walk2?	No
	X Walk 1 Direction	To NW		X Walk 2 Direction	To SW
N/A	X Walk 1 Width (in)	N/A	N/A	X Walk 2 Width (in)	N/A
	X Walk 1 Slope (%)	3.8		X Walk 2 Slope (%)	1.1
	X Walk 1 X Slope (%)	1.1		X Walk 2 X Slope (%)	3.3

N/A	Ramp inside XWalk1?	N/A	N/A	Ramp inside XWalk2?	N/A
	Road Slope (%)	2.3	N/A	Clear Space?	N/A
	Road X Slope (%)	2.8	N/A	Clear Space to XWalk (in)	N/A
N/A	Any Obstructions?	N/A	N/A	Storm Grate/Utility Hazard?	N/A
	Obstruction Type			Storm Grate/Utility Type	
		N/A			N/A
			Yes	Surface Condition? (G/P)	Good

Remove & Replace Curb Ramp With Two New Directional Ramps or Equivalent.
